Rail Accident Report

Head-on collision between a passenger train and a freight train
in Tempi, 28 February 2023

RL01-2025, 27 February 2025

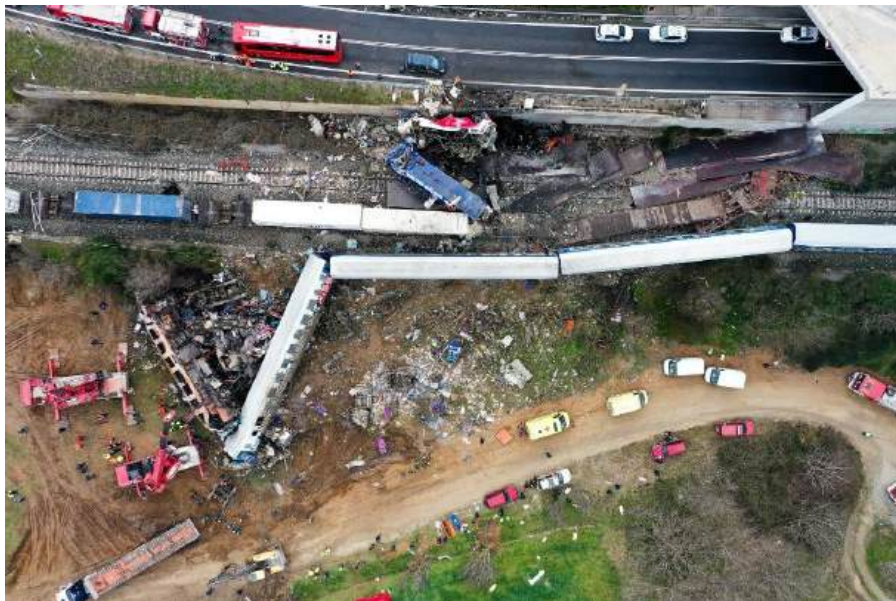
Figure 10. The end position of the 3 locomotives and some of the passengers coaches and freight wagons (<http://www.intime.gr/>).

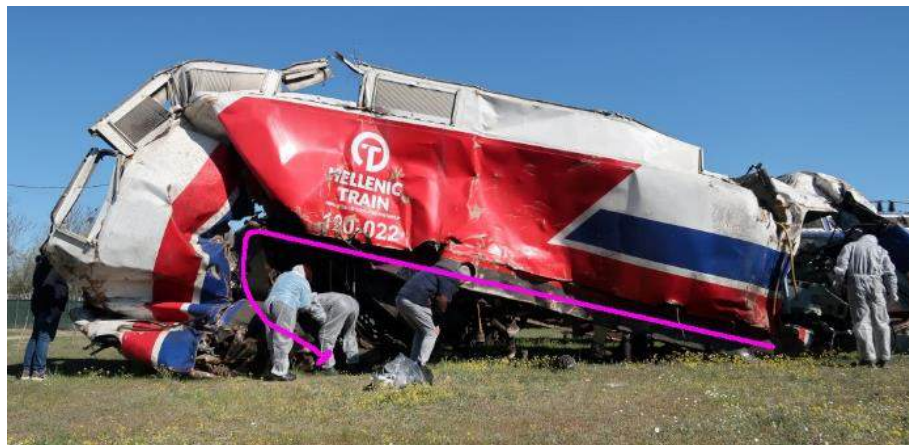
Figure 14. The first locomotive of the freight train (120-022) showing extreme damage from the very heavy head-on collision with the locomotive (120-023) of the passenger train.

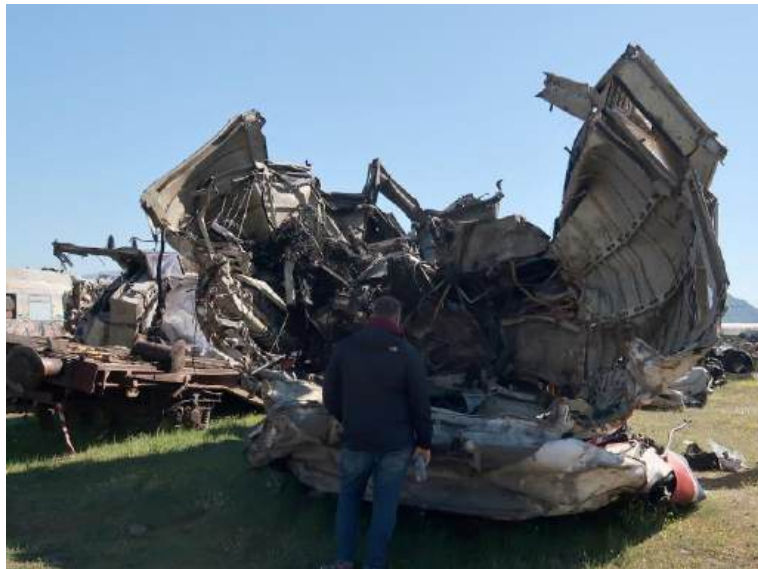
Figure 16. Front view of the locomotive 120-022, roof missing.

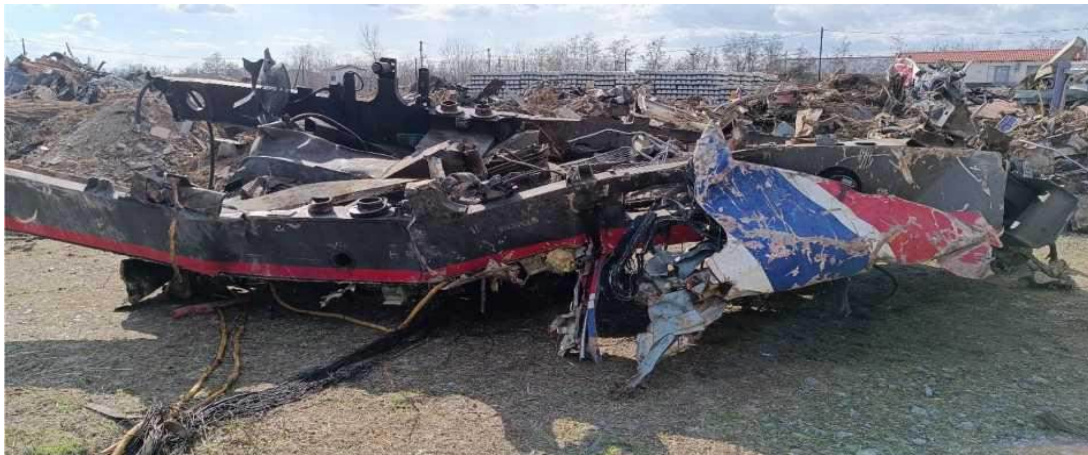
Figure 17. Part (chassis) of the completely destroyed locomotive 120-023 of the passenger train IC-62.

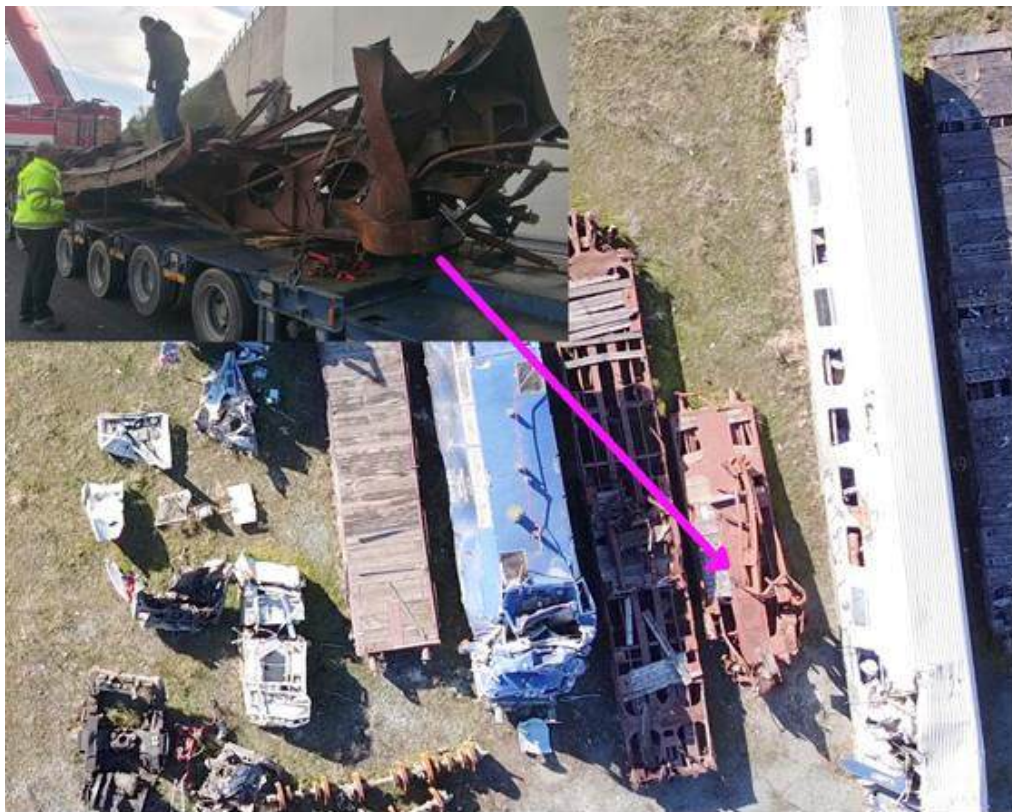
- 135 The rear part of the first platform wagon can be identified among the remains of the vehicles at Koulouri, but the front part is not available for examination, as it was presumably cut in smaller pieces in order to allow easy transport (Figure 19). This action was not documented in any way and there are no photographs of the carriage in its original condition at the crash site before being cut up and moved by an unknown party.

Figure 19. Remains of the first platform that was carrying steel plates.

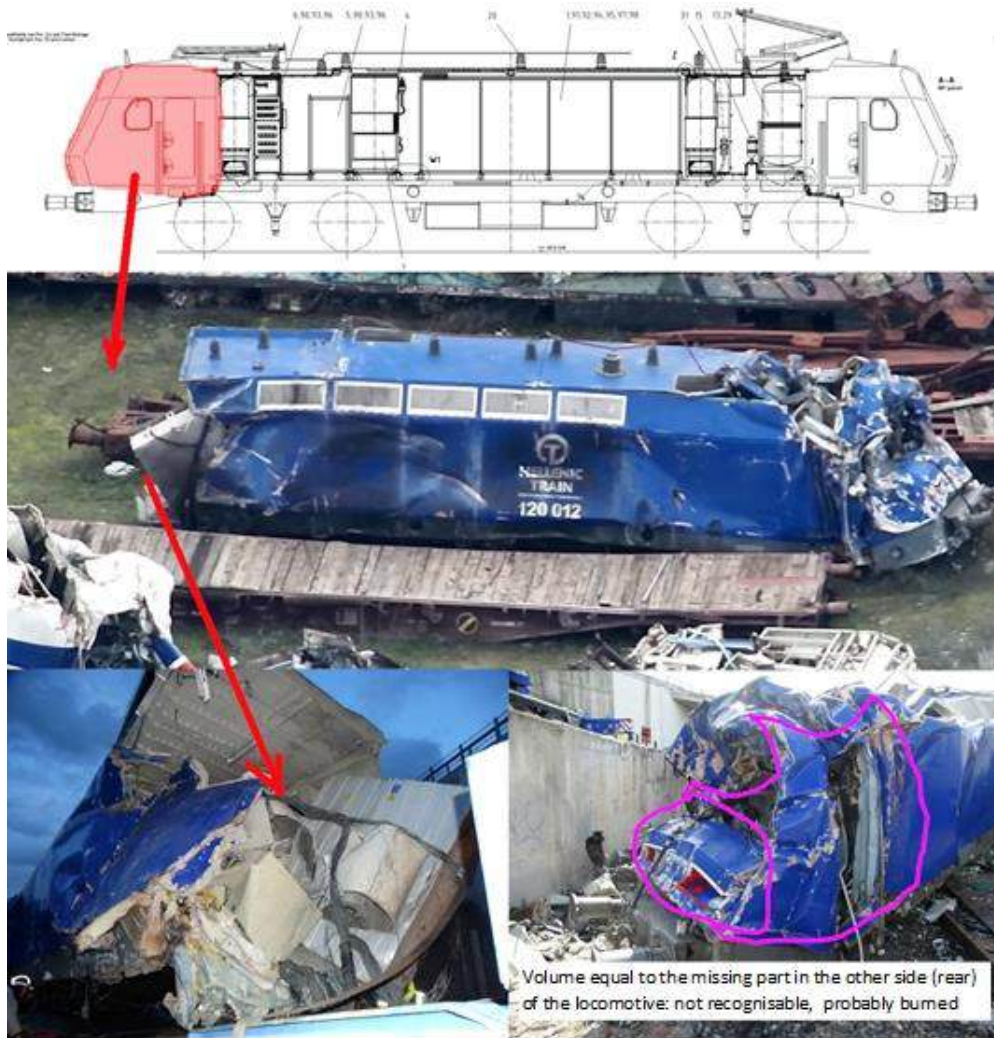
136 The rear driver's cabin of the 120-012 locomotive appears to be cut off from the rest of the vehicle and it cannot be completely identified anywhere among the debris, apart from a small part of its roof and top headlight (in front of the first container). The rest of the cabin cannot be identified as a whole and also the front panel with the painted number and the two red headlights are also not recognisable among the debris. Presumably, the missing structure is among the crashed and burned remains of the Restaurant Car, as this is the only place in the whole accident site where the fire burned so fiercely that it totally consumed the heavy industrial-grade paint of the blue locomotive, making it unidentifiable.

Figure 20. Missing rear-end of the locomotive 120-012.

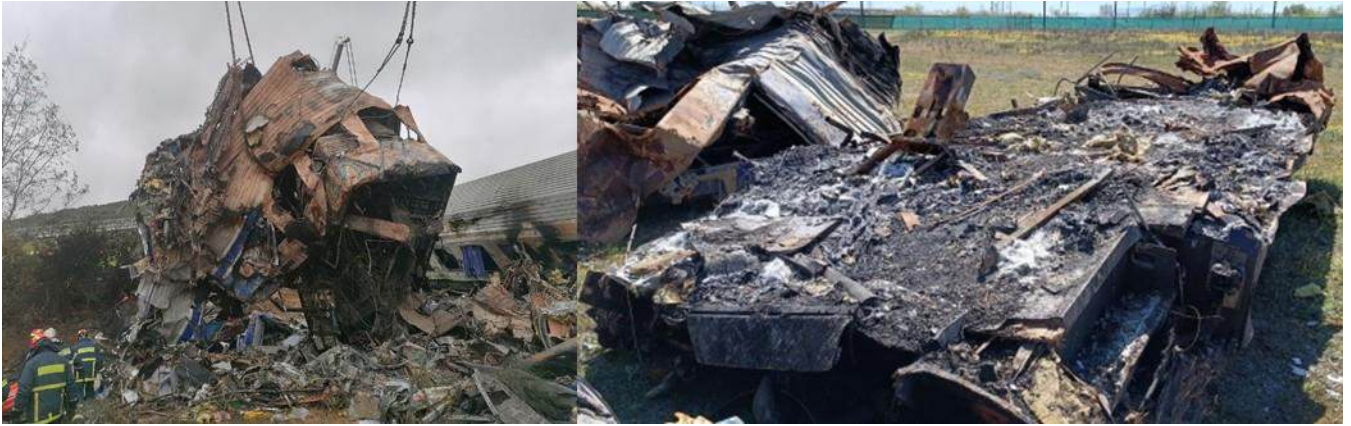
137 This second collision causes very heavy damage to the Restaurant Car (Figure 21) that is bent into an S-shape mostly due to this initial impact but also sustaining damage while rolling and hitting the ground on its way to the lower verge, to end almost on top of the remains of the locomotive 120-023 and the destroyed A1 first-class coach.

Figure 21. Remains of the Restaurant Car, on the left, S-shaped as found on-site, and on the right, its platform at Koulouri site.

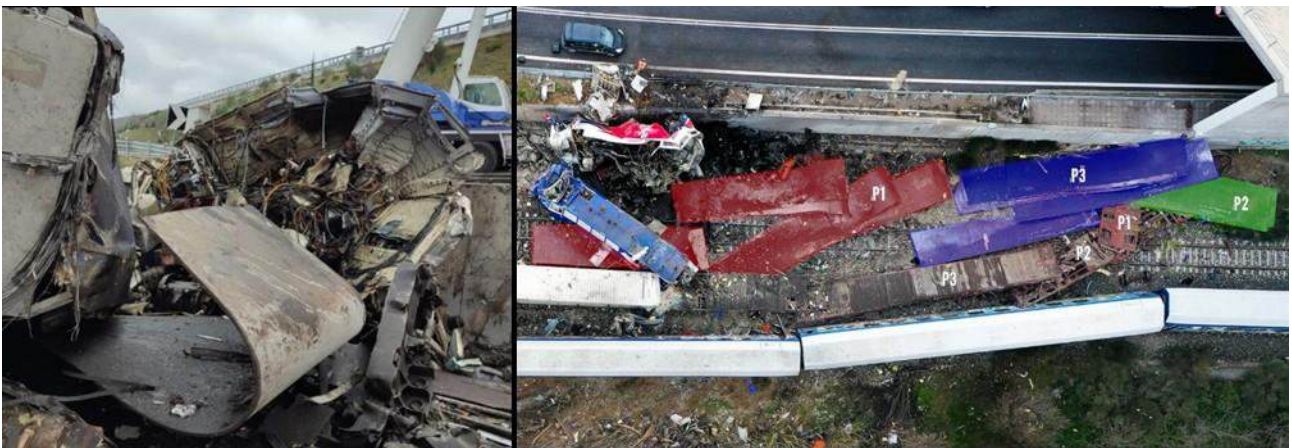
138 By comparing the damage to the steel plates and the Restaurant Car, it can be considered as most likely that the initial impact to the Restaurant Car came not on its front bumper but underneath its “belly”, indicating that the Restaurant Car had a slightly “nose-up” attitude at the moment of the impact, which is consistent with the damage observed on the first and presumably topmost steel plate that was found wedged underneath the blue 120-012 locomotive. Meanwhile, the 1st platform of the freight train sustains very heavy damage from the impact with the Restaurant Car that leaves it bent in half and wedged under the remaining steel plates against the wall, and spread few meters after the collision, in the area before the entrance of the tunnel. (Figure 13, Figure 22).

Figure 22. Remains of the top steel plates and final position of the 3 sets of steel plates.

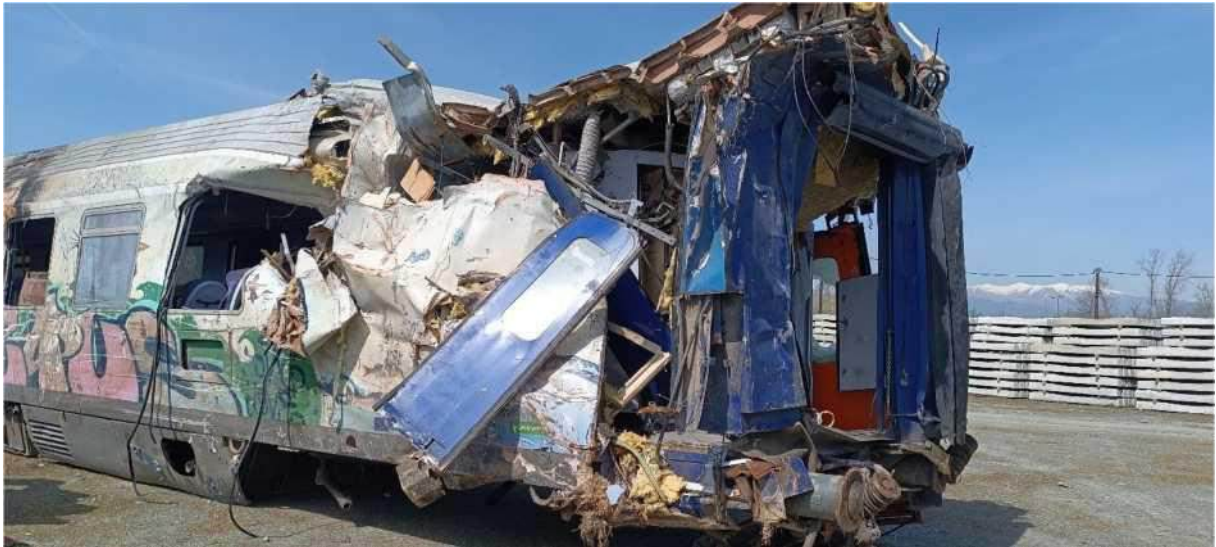
140 Derailed by the collision of the Restaurant Car, the B2 vehicle (a passenger coach divided into 11 6-seat compartments) continues straight ahead with a slight angle to the train tracks, nose diving downwards and hitting the ground with its front end, bending and breaking off its front section in the middle of compartment no 2. After the head-on impact, the rear of the wagon is lifted high and to the left and coming down to hit the front of the B3 passenger coach.

Figure 23. Remains of the B2 coach

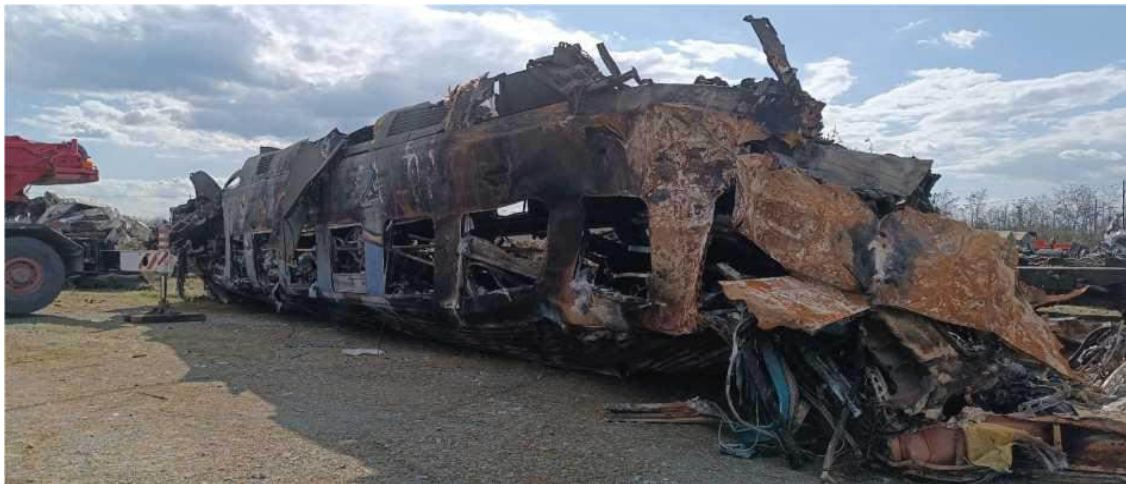
- 141 This B3 coach, in the meantime is derailed and veering to the left, its front end moving downhill and cutting down small trees and bushes, while its rear end is pushed straight ahead by the B4 coach (still attached to each other), creating a rotation to the left for the B3 carriage that comes to a stop at an angle when its side hits the debris of the A1 coach and the broken up Locomotive.
- 142 The impact of the B2 (Figure 23) on the top of the B3 wagon (Figure 24) causes the rear part (11th compartment) of the B2 coach to break off and fall below, while at the same time it causes severe damage to the B3 coach underneath.

Figure 24. Remains of the B3 coach

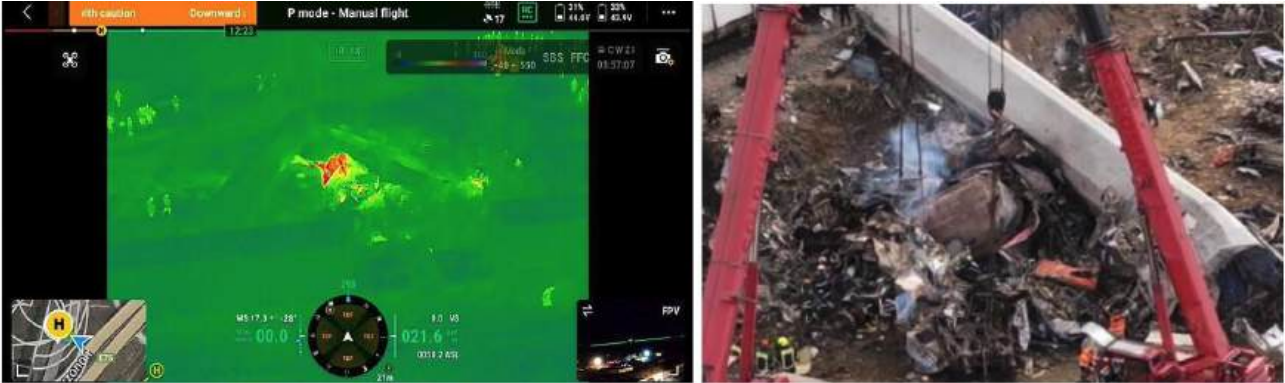
Figure 32. Fire simmering inside the Restaurant Car for 12 hours.

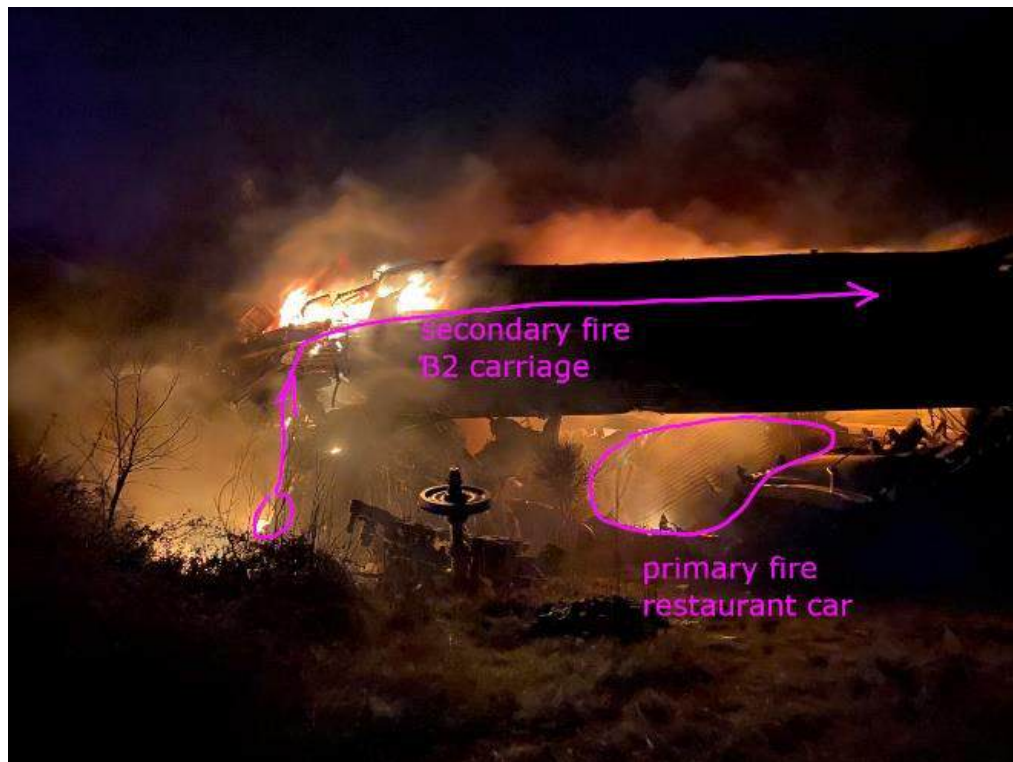
Figure 33. Another fire started at the front of the B2 coach.

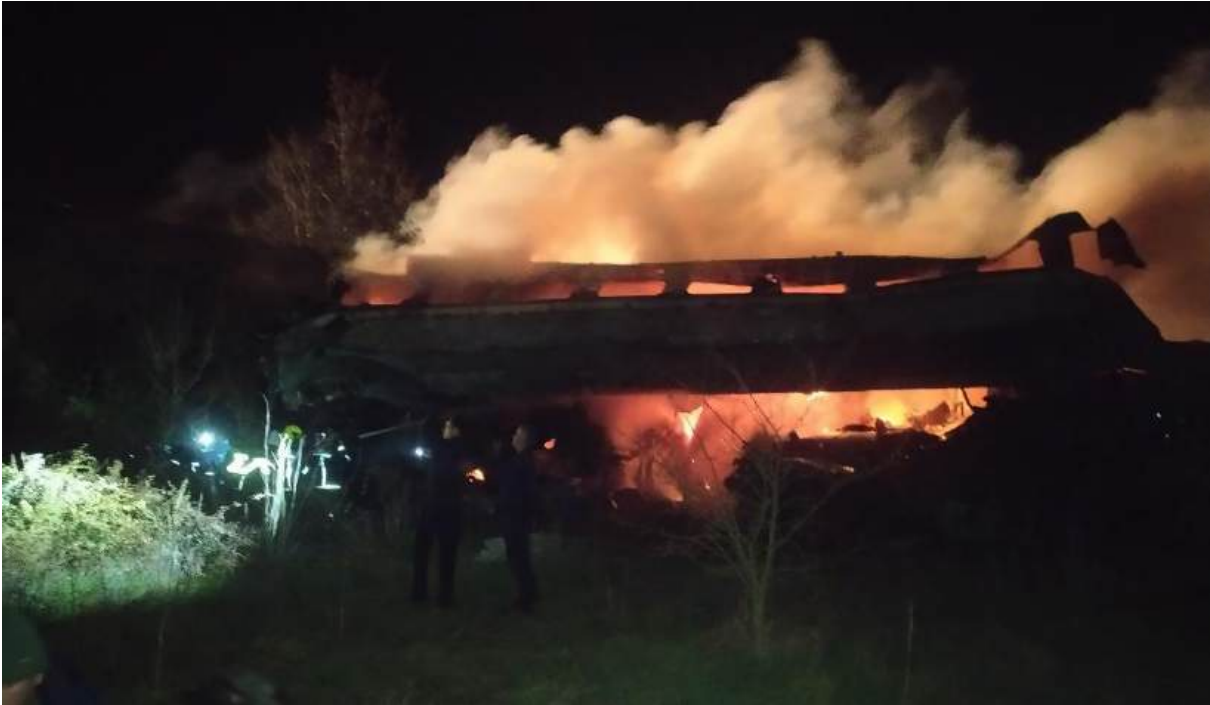
Figure 34. Photo showing the heavy fires in the Restaurant Car area (behind), and on the B2 coach (front, above) (Source: EDAPO).

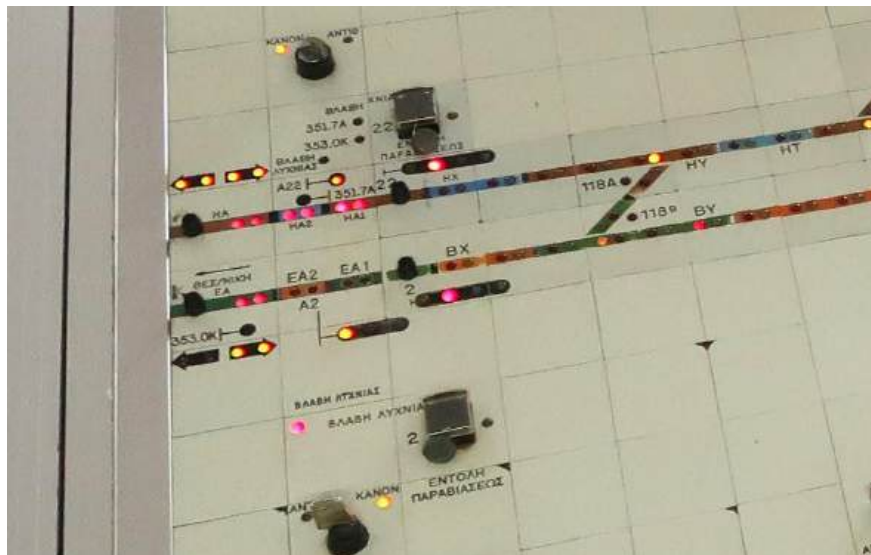
Figure 49. Section EA3 (indicated EA to the left of EA2 on the picture) of the control panel incorrectly indicating an occupation.

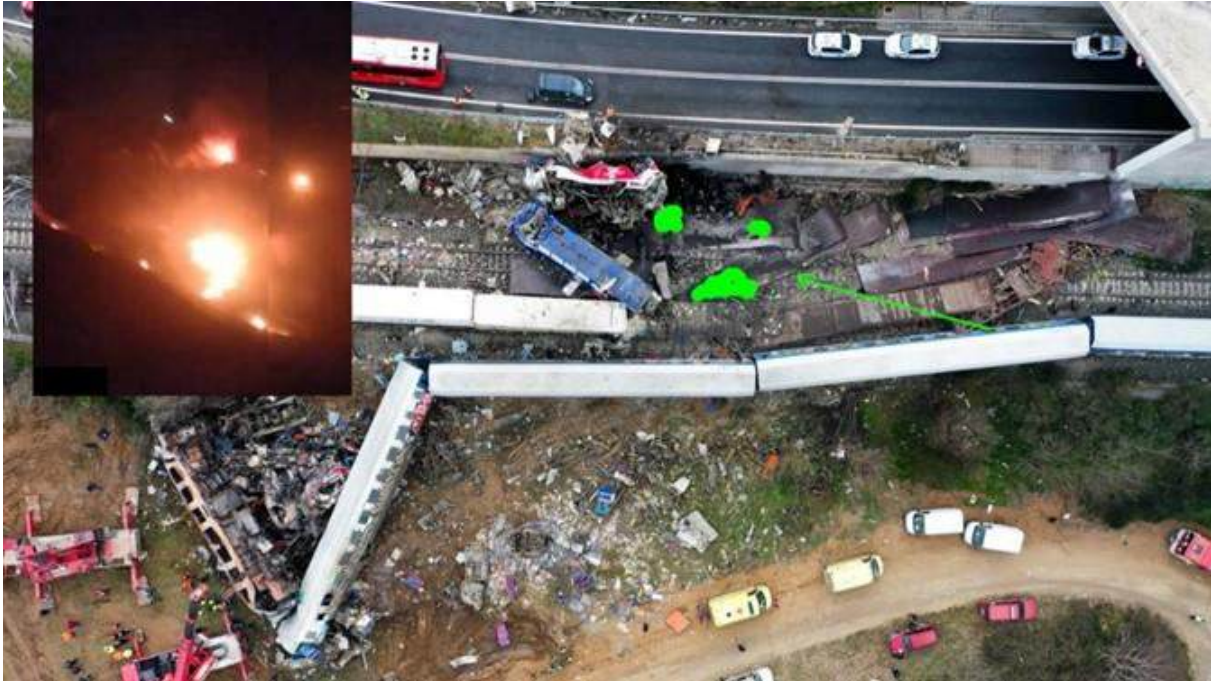
Figure 64. Fire inside the transformer of freight train as a secondary result of pool fire #1.

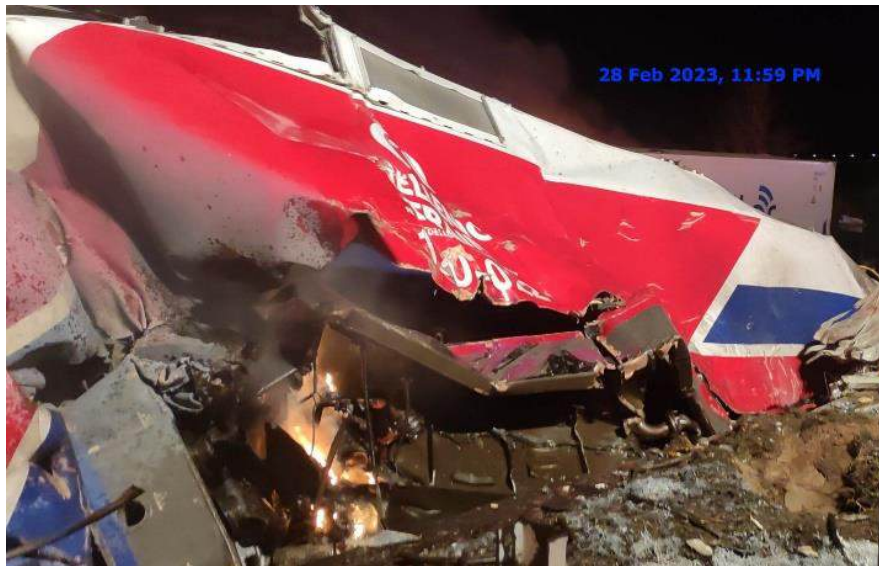
Figure 65. A local fire inside and outside the broken transformer of the first locomotive of the freight train, 40 minutes after the accident.

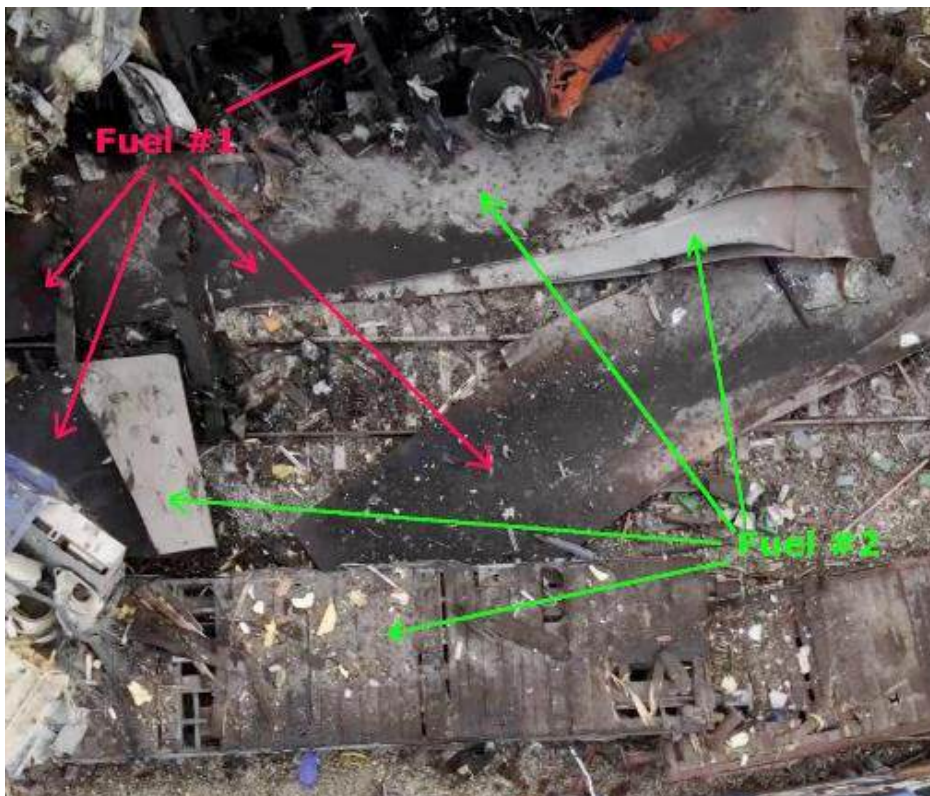
Figure 66. Evidence of two different fuels burning in the pool fire #1, one leaving black, the other leaving white residue.

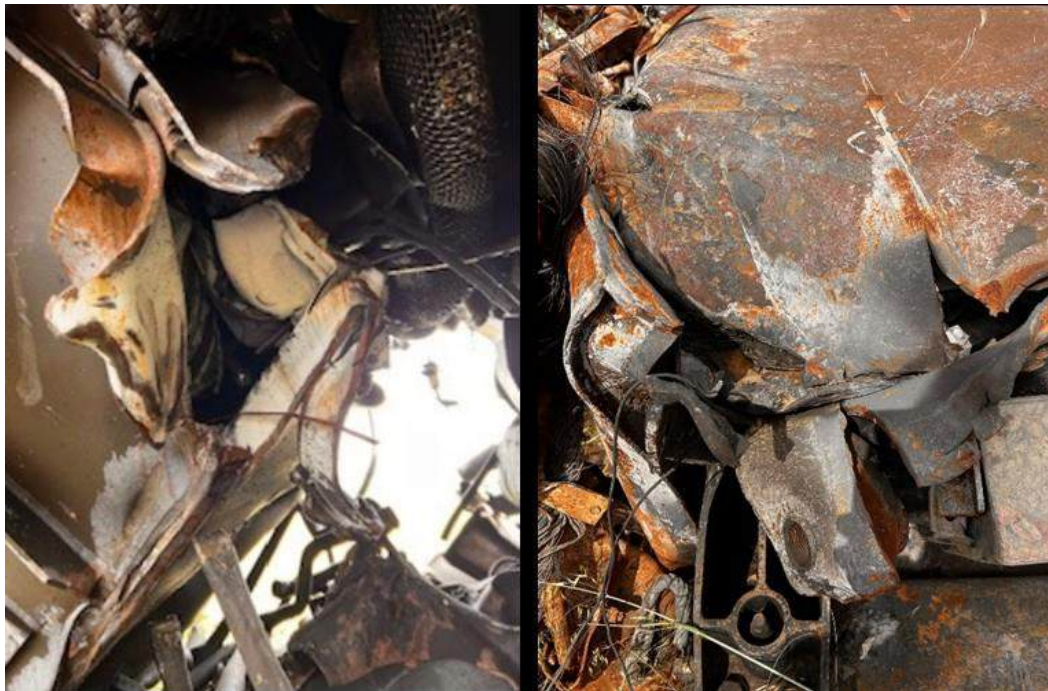
Figure 67. Large cracks of the transformer still attached under the 120-022 locomotive (Left). Bumps, folds, rips and large cracks of remaining locomotive transformer 120-023 (right), see also Figure 61.

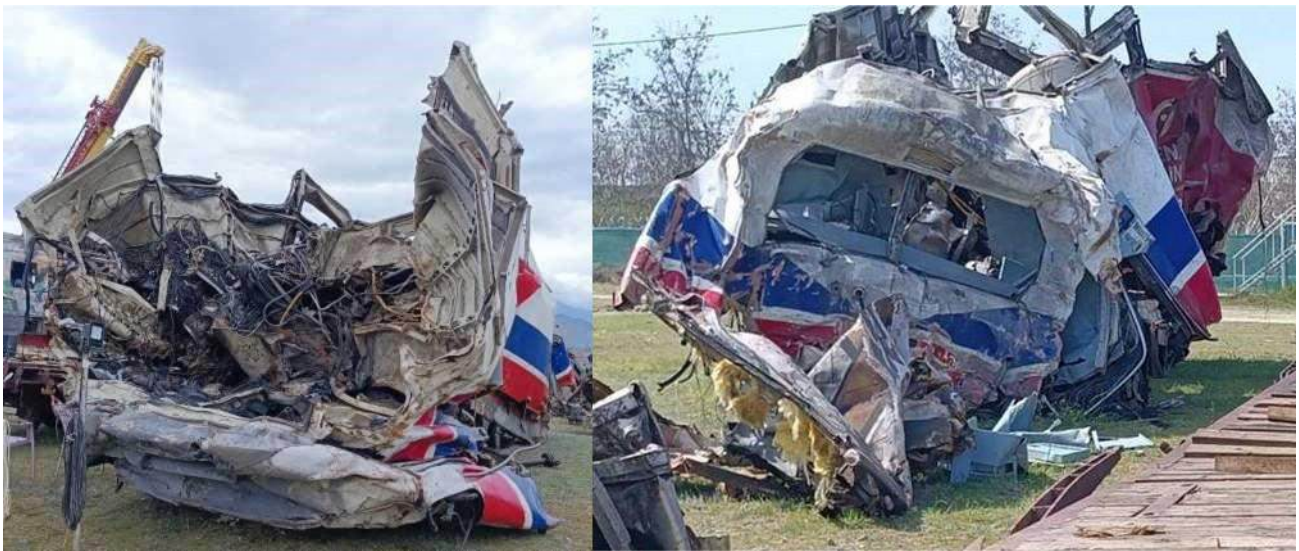
Figure 77. Position 1) Siemens Hellas Sprinter 120-022- NVR Engine: 91 73 212 0 022-7 Extreme damage on the front, roof missing, and rear heavily damaged from the rear collision with the attached locomotive 120-012. Rear view in Figure 14.

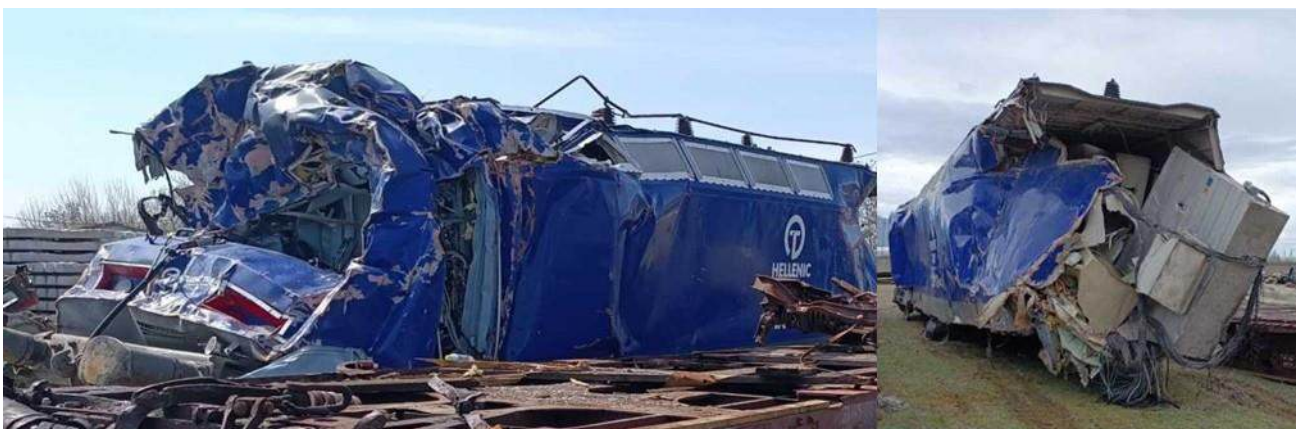
Figure 78. Position 2) 120 012 locomotive, heavy damage in the front (with locomotive 120-022) and rear, signs of crash against 1st container on P4, without the missing rear cab.

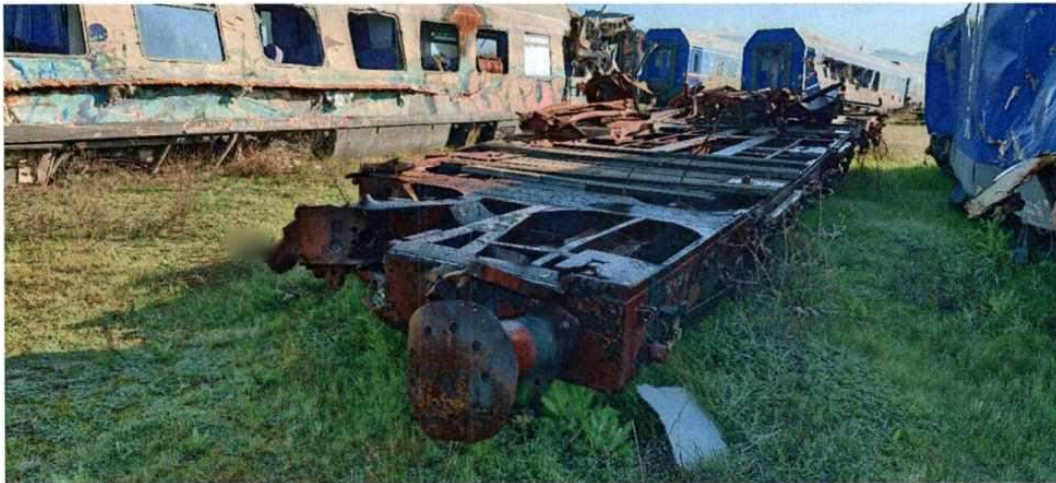
Figure 79. Position 3) nr 1 platform carrying steel plates, front half totally destroyed by heavy impact with Restaurant Car.

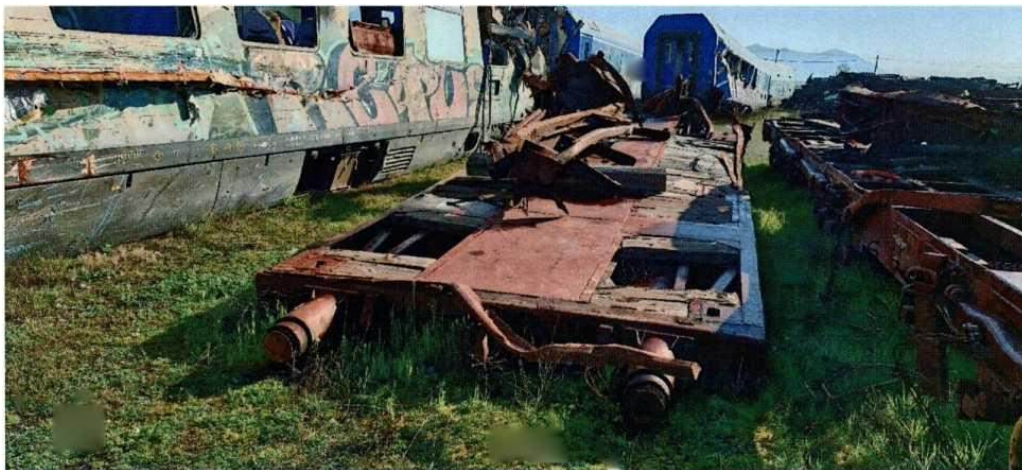
Figure 80. Position 4) nr 2 platform carrying steel plates, lost bogies from derailment but very slightly damaged, no signs of heavy crash.

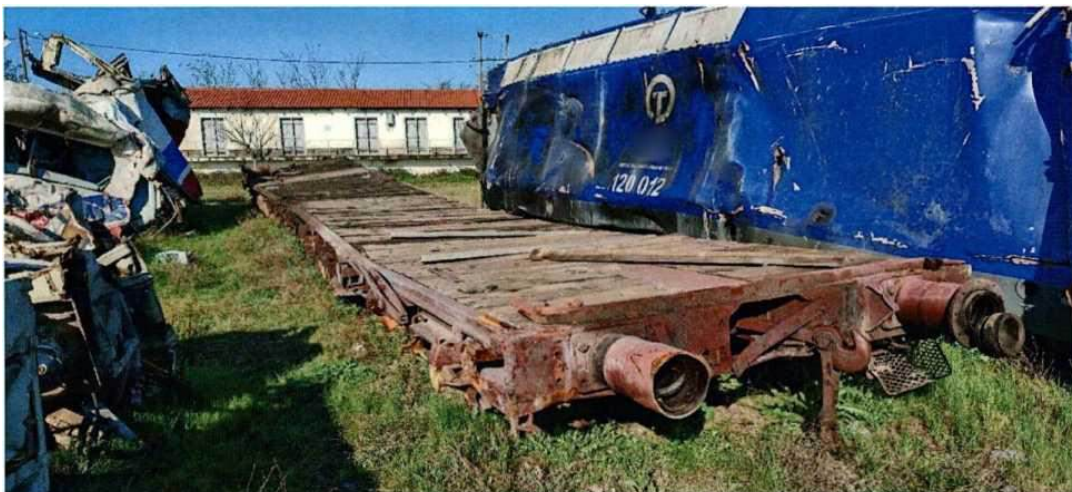
Figure 81. Position 5) nr 3 platform carrying steel plates, lost bogies from derailment, slight damage (twist) due to crash from the rear.

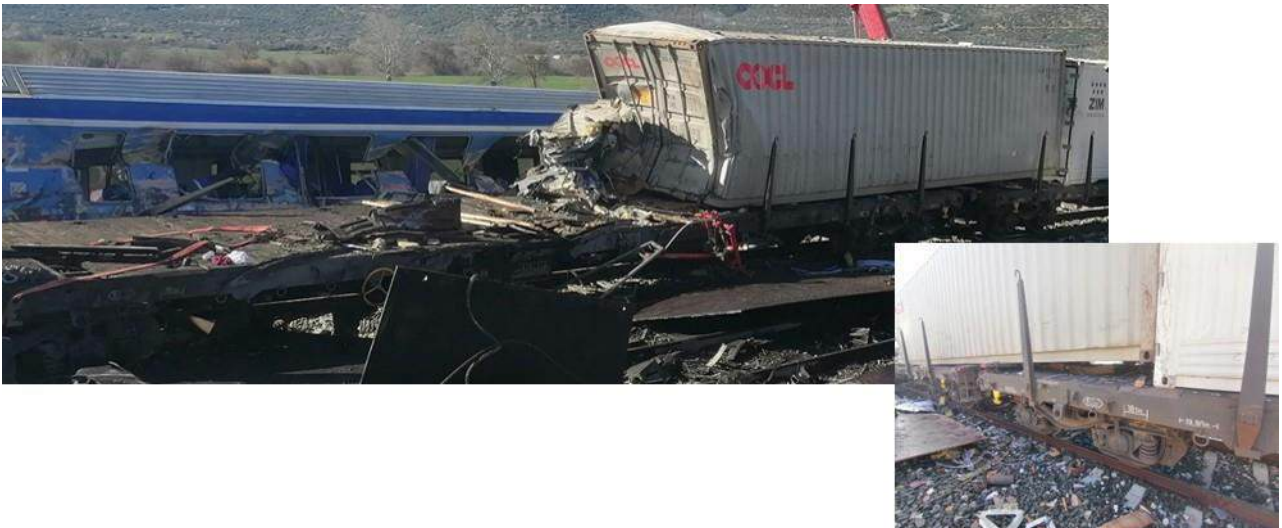
Figure 83. Positions 6) and 7) – on the left, the platform nr 4 (damaged, lost front bogie, not derailed) carrying the first container. On the right, the first container (OOCL) is shifted in rear direction, hurting the next container (ZIMonitor).

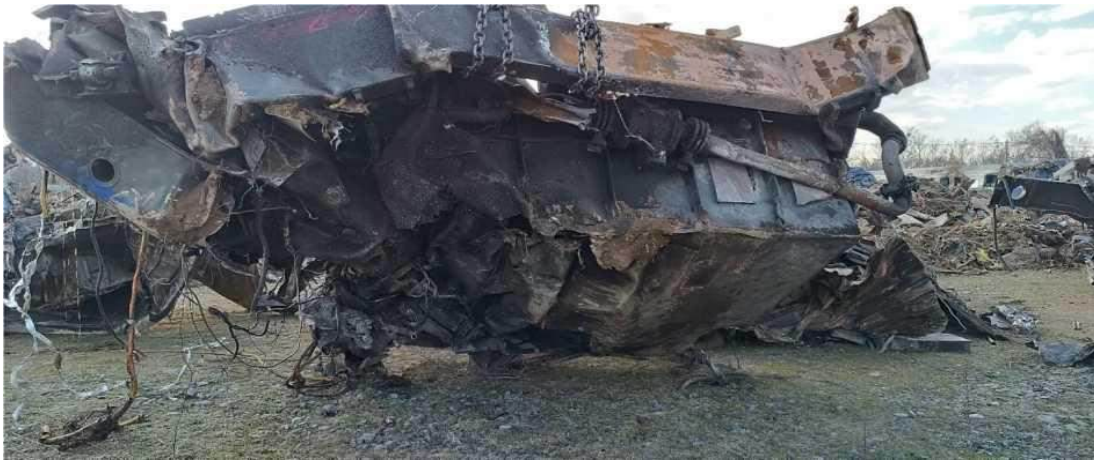
Figure 85. Position 1) 120 023 locomotive, totally destroyed, broken into large pieces. Remaining piece of the basement platform. Part with transformer still visible. Other side in Figure 17. At the position 2) the A1 1st class coach, totally destroyed, has broken into small pieces, and was not recognisable as a whole vehicle.

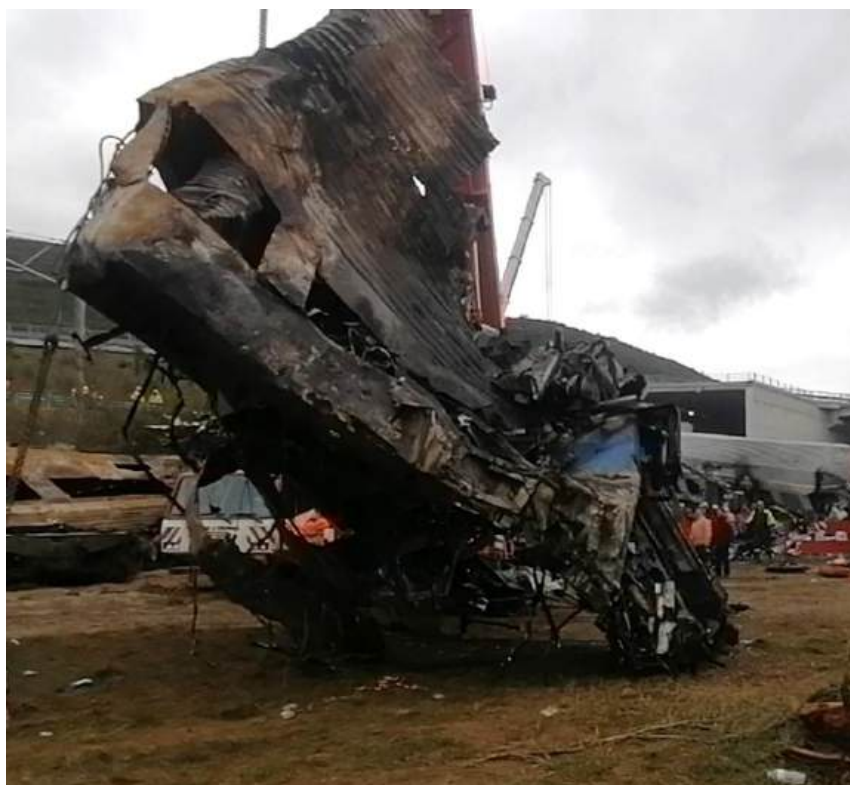
Figure 86. Position 3) Restaurant Car, very heavily damaged from initial crash (folded, bent into S-shape) and burned down. Here, suspended from the crane cables.

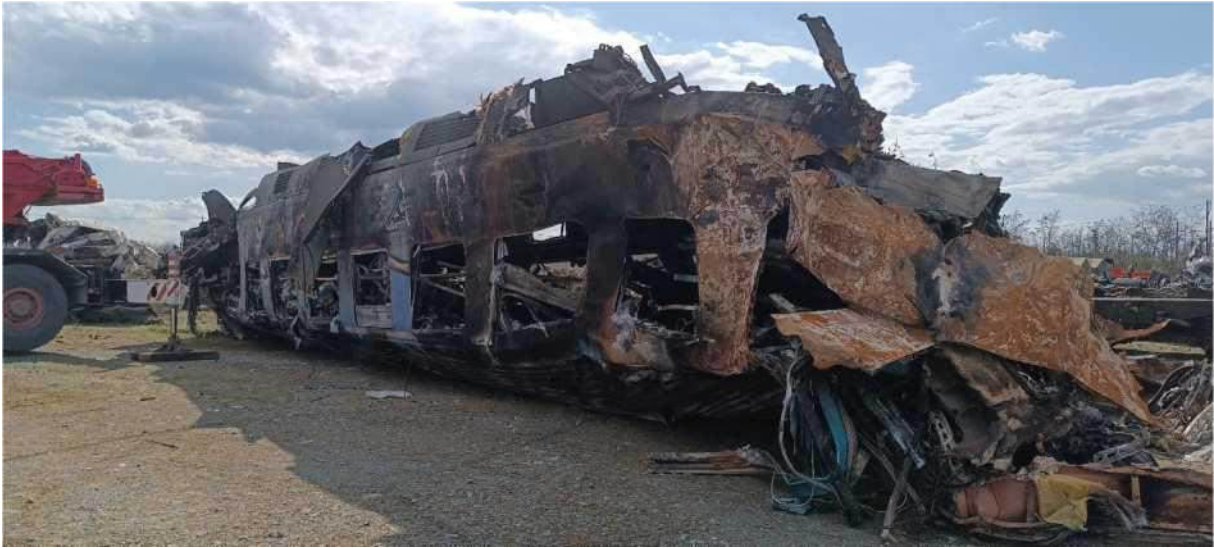
Figure 87. Position 4) B2 2nd class coach, heavy impact damage in the front and rear, fire slowly consumed it.

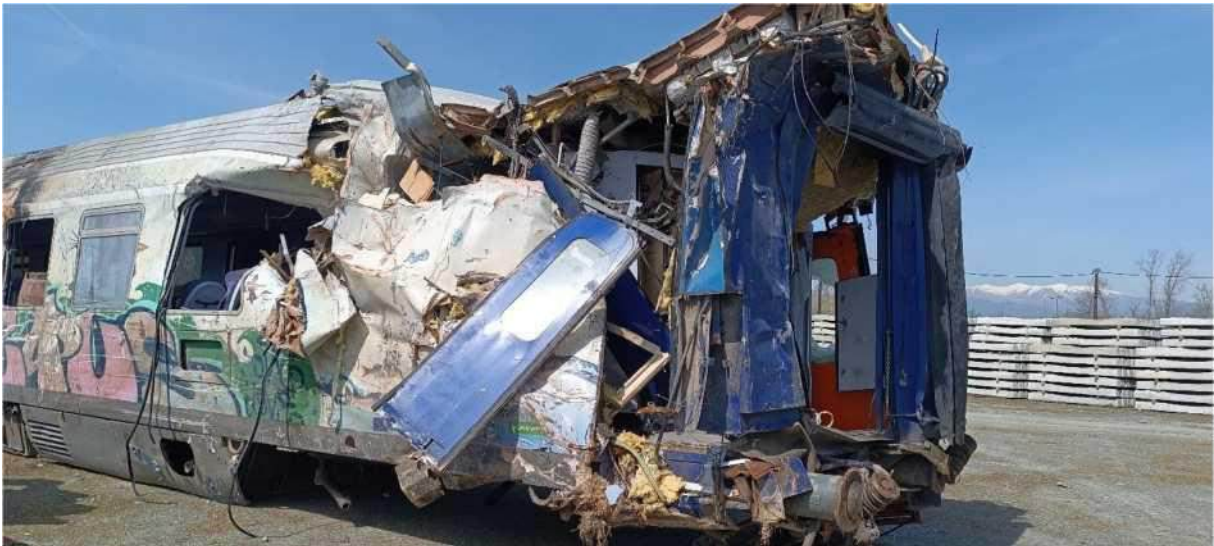
Figure 88. Position 5) B3 2nd class coach, derailed and went down a slope, lost bogies, no other damage from derailment or crash, specific impact damage from B2 coming down from above.

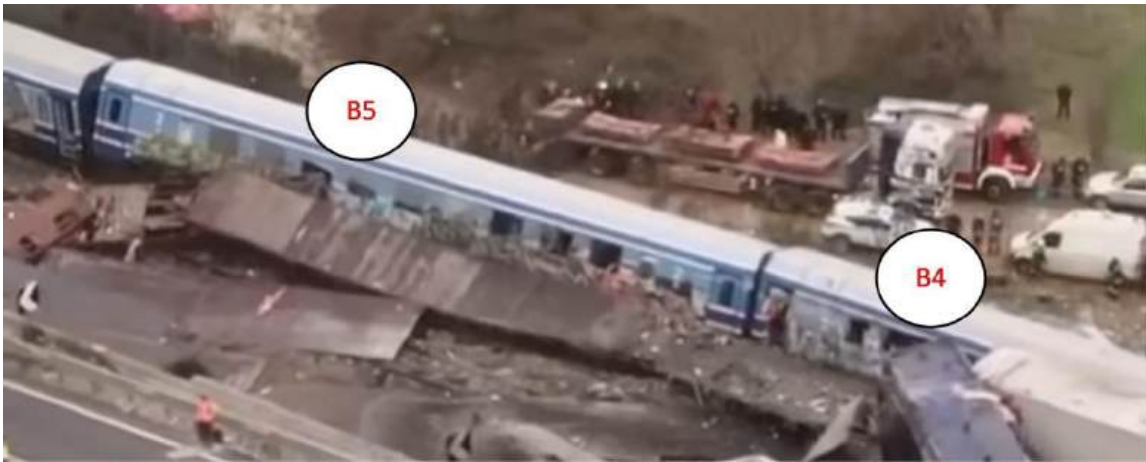
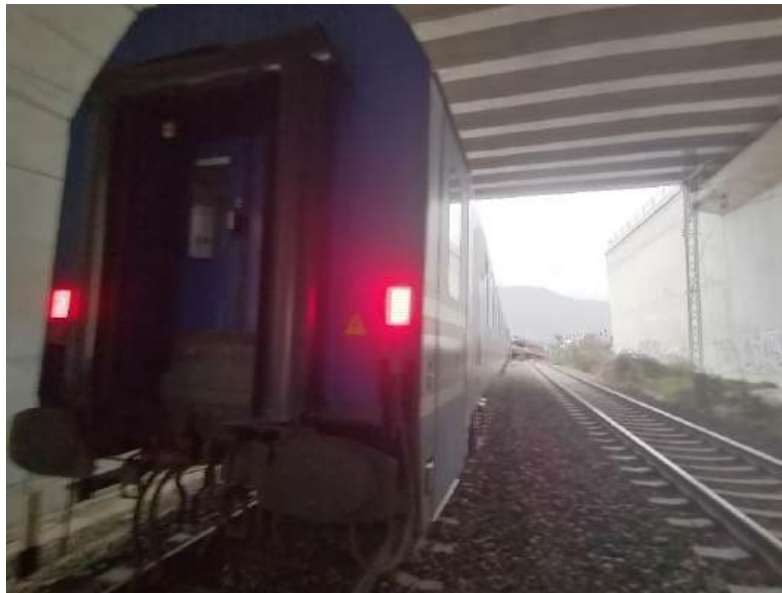
Figure 89. Positions 6-9) B4-B7 coaches, B4 and B5 derailed and were hit on the side by steel plates, B6 and B7 did not derail, no damage, B7 remained nearly all in the tunnel.
