Rail Accident Report

Head-on collision between a passenger train and a freight train
in Tempi, 28 February 2023

RL01-2025, 27 February 2025

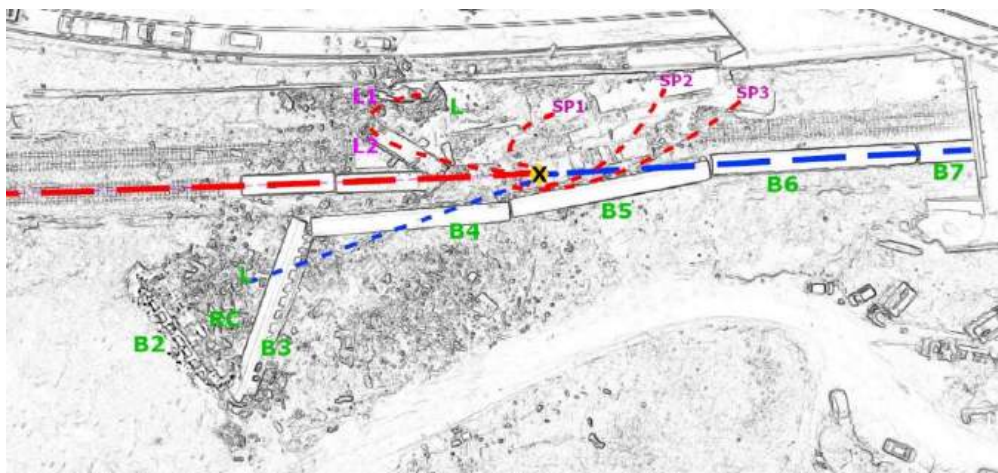
- 130 The 1st phase mainly involved the first 4 vehicles of the two trains: 2 locomotives 120-022 (first) and 120-012 (second) of the freight train and the locomotive 120-023 with its first-class A1 coach. The initial impact is a head-on collision between passenger train locomotive 120-023 and the first freight train locomotive 120-022, that causes the latter, along with the second locomotive 120-012 to be catapulted towards their left over the upward line track and smashed against the motorway wall, with the second locomotive making a U-turn and its rear end sliding over the steel plates carried on the 3rd platform of the freight train to come to a standstill with its front side against the first locomotive and its rear end resting against the first shipping container carried on top of the 4th platform of the freight train (Figure 10, Figure 11, Figure 12).

Figure 11. Global movement of the collision, with the initial impact and catapult effects. (SP1,2,3 are Steel Plates, and were also catapulted)

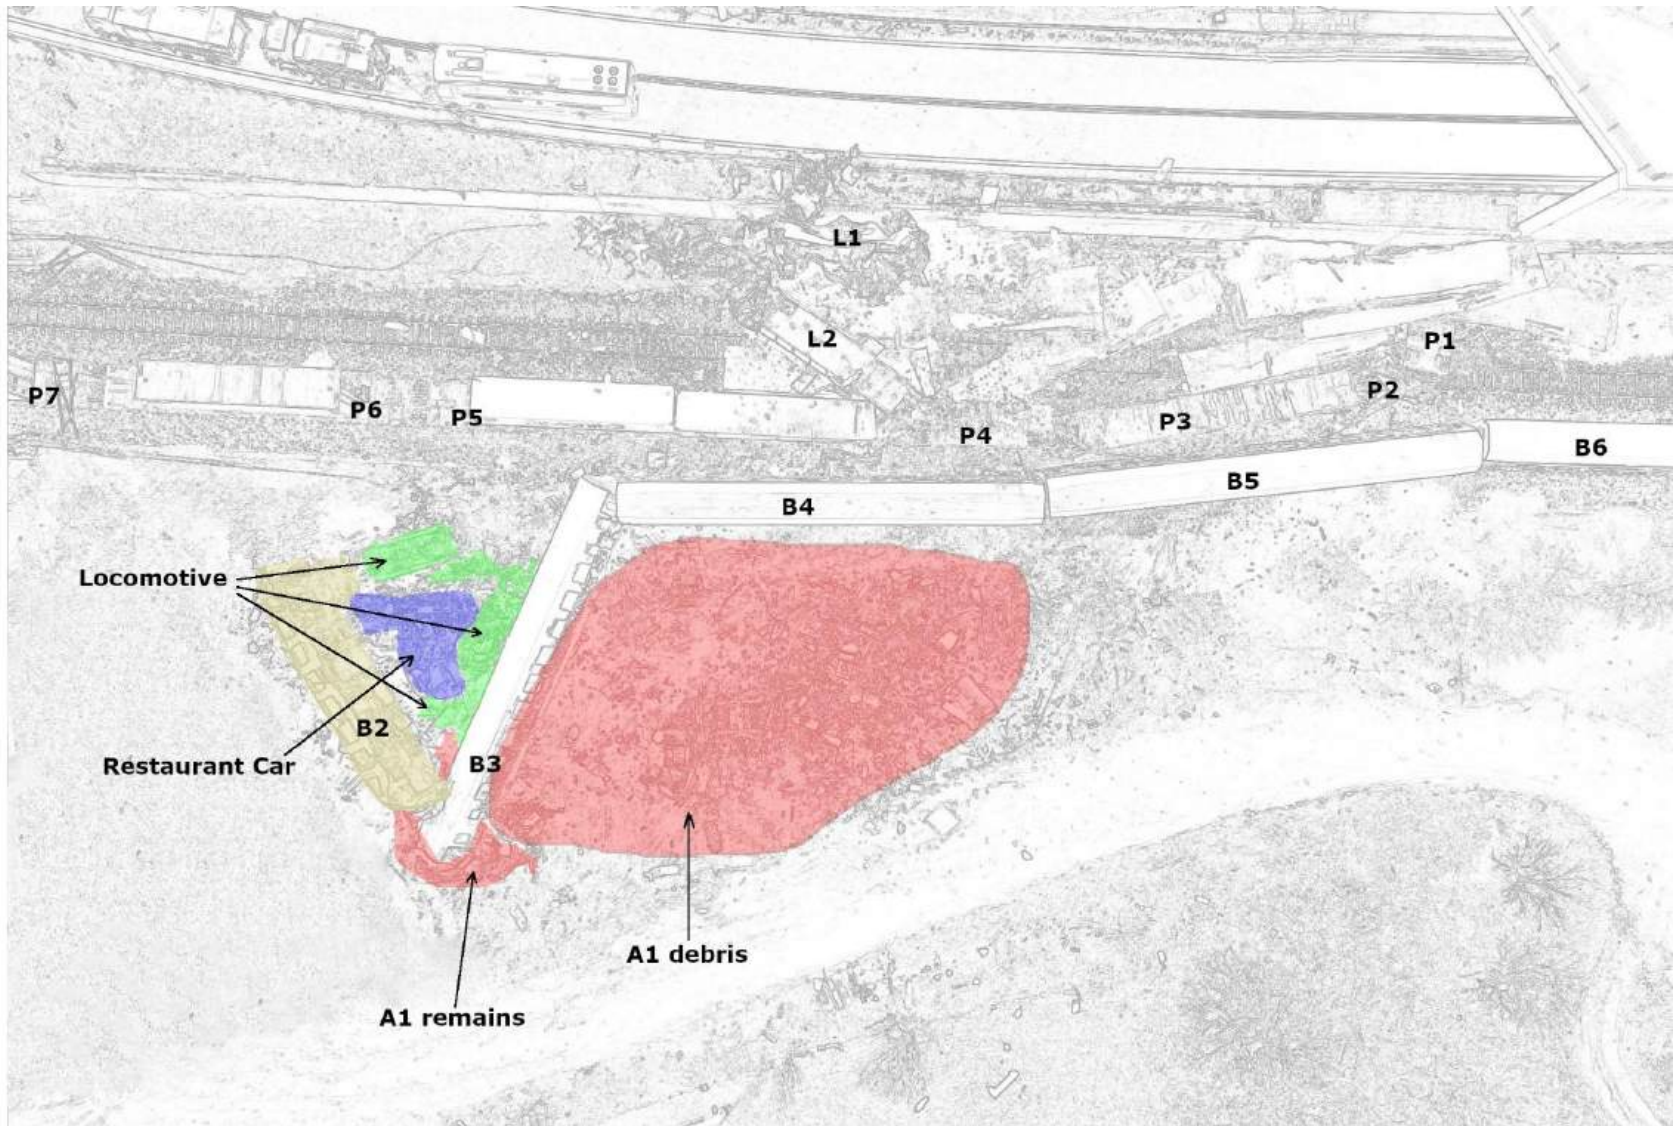
Figure 12. The accident site.

Best estimated point of the 1st collision: X, Freight locomotive 120-022: L1, and 120-012: L2, Passenger train locomotive 120-023: Locomotive areas, First-class A1 coach: A1 areas, Restaurant Car area, Second-class B2 on B3 head, then B3, B4, B5, B6, (B7 under the tunnel), Freight train platforms P 1-2-3-4, and freight wagons 4-7 (and other 6 not on the figure).

- 132 The passenger train locomotive 120-023 follows a slightly leftward path in its driving direction towards the lower verge, where it hits the ground, followed by the first-class passenger car. Due to the very heavy initial impact, this 120-023 locomotive has been completely destroyed (Figure 17), and its parts were found at an angle of approximately 20 degrees to the left and at a distance of 30 to 45 meters. The A1 coach of the passenger train was completely broken up due to the extreme mechanical loads of the impact and its heavier parts followed a path close to the path of the locomotive parts, at an approximate angle of 25 to 30 degrees to the left. Its lighter parts (seats, internal panels and fittings, luggage, and all casualties) were scattered in a wider area before the end position of the vehicle (see global Figure 12).

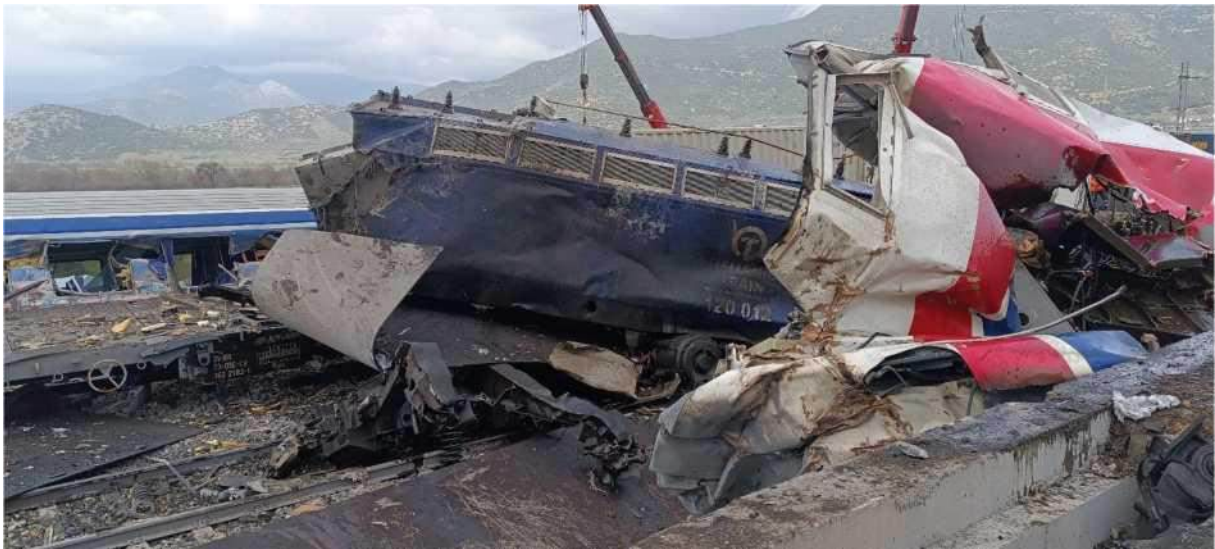
Figure 13. Locomotives 120-022 and 120-012 of the freight train 63503 after the accident. Front view, from the road.

138 By comparing the damage to the steel plates and the Restaurant Car, it can be considered as most likely that the initial impact to the Restaurant Car came not on its front bumper but underneath its “belly”, indicating that the Restaurant Car had a slightly “nose-up” attitude at the moment of the impact, which is consistent with the damage observed on the first and presumably topmost steel plate that was found wedged underneath the blue 120-012 locomotive. Meanwhile, the 1st platform of the freight train sustains very heavy damage from the impact with the Restaurant Car that leaves it bent in half and wedged under the remaining steel plates against the wall, and spread few meters after the collision, in the area before the entrance of the tunnel. (Figure 13, Figure 22).

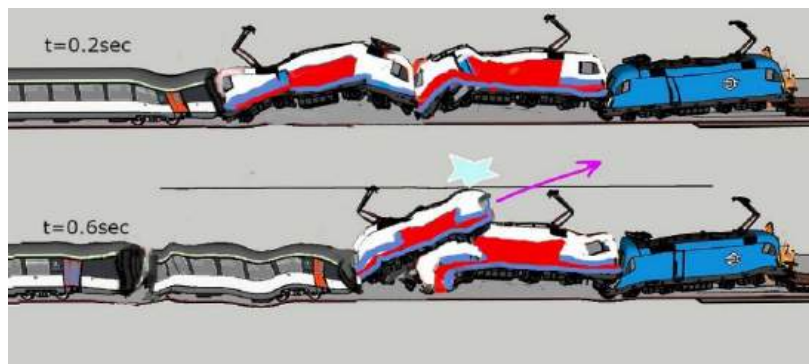
- 131 From the examination of the remains of the first freight train locomotive 120-022, it is clear that the head-on collision bent the front bumper downwards and inwards (Figure 14, Figure 15), severely bending the heavy beams of the lower frame of the locomotive, while at the same time the fact that the roof is missing (Figure 16), is an indication that the passenger train locomotive 120-023 passed over and through the roof of the this 120-022 locomotive.

Figure 15. Movement of the passenger train locomotive 120-023 over and through the roof of the freight train locomotive 120-022.

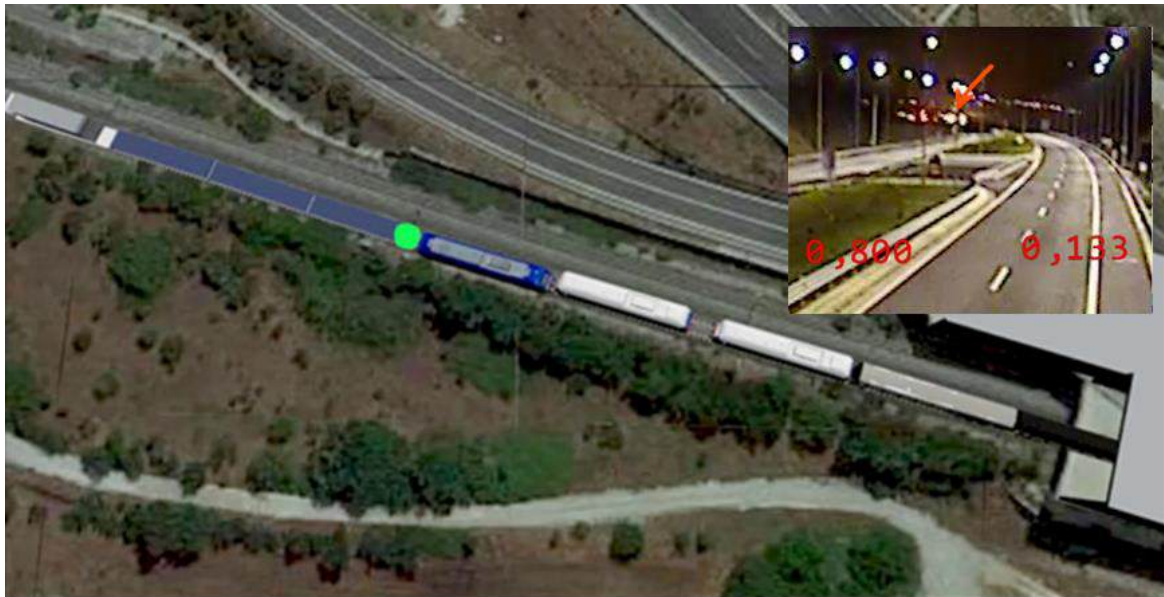
- 134 The second collision is another heavy head-on collision that takes place between the Restaurant Car (i.e. the 3rd vehicle) of train IC-62 and an area between the rear end of the locomotive 120-012 and the first of the wagons carrying steel plates (Figure 18). The effort to locate and examine all the remains of the corresponding vehicles of the freight train, shows that it is not possible to locate and identify all these parts.

Figure 18. Estimated area for second collision for the freight train (simulated image behind still of video footage).

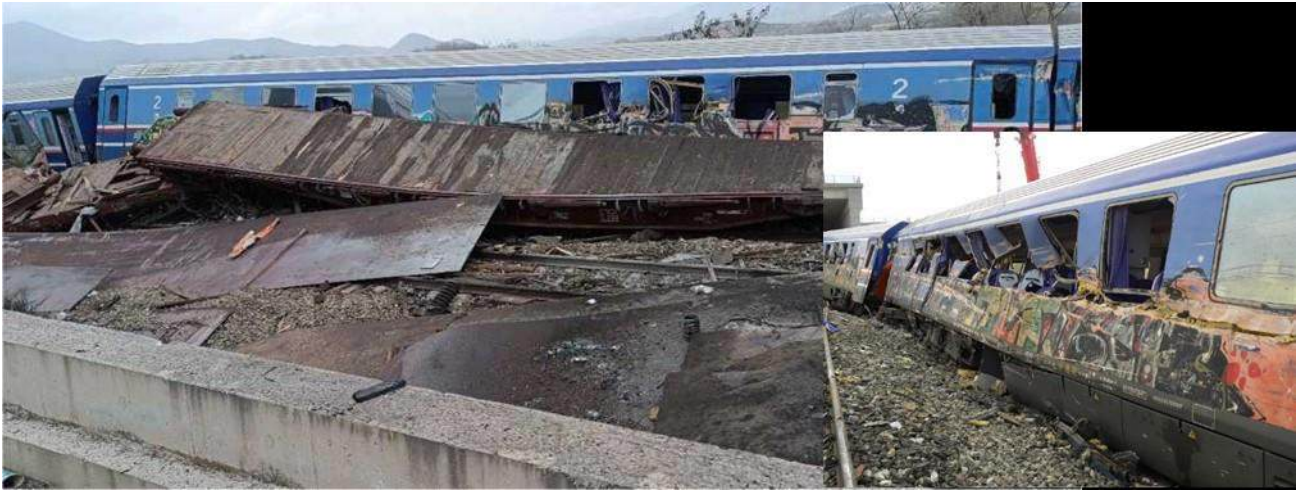
- 143 Meanwhile, the remaining 12 vehicles of freight train 63503 and the remaining 4 vehicles of IC-62 continue their last part of their forward movement, where in addition to braking action there is also side impact between the steel plates and the sides of the 2nd and 3rd platform and the sides of the B3, B4 and B5 coaches of the passenger train (Figure 25).

Figure 25. Linear impact of steel plates on the side of the coach B4.

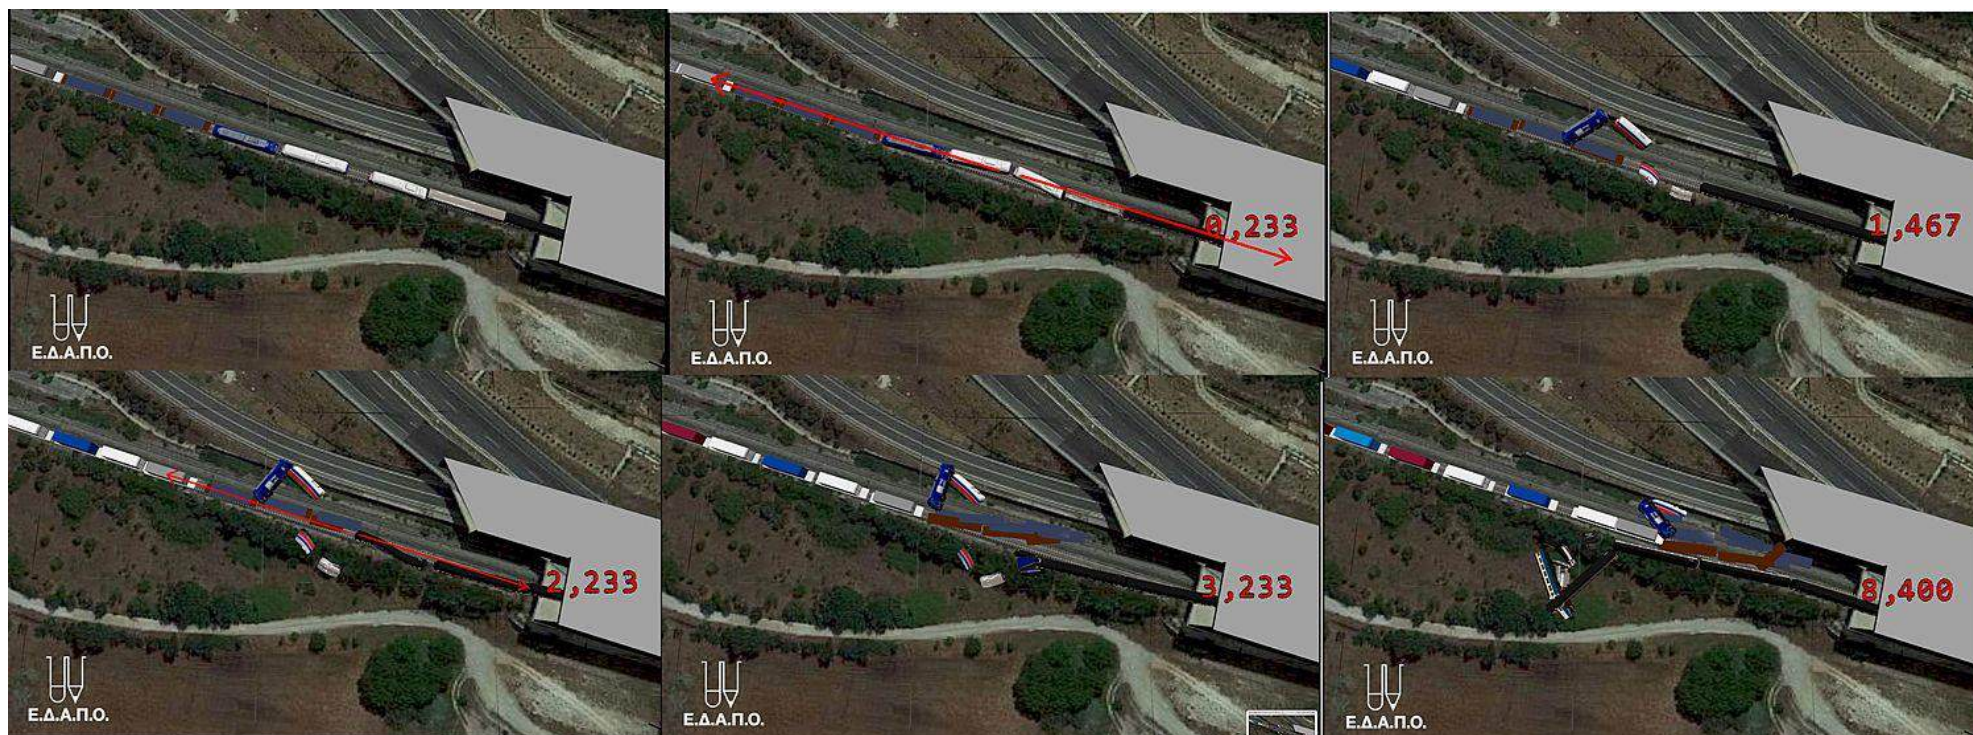
- 144 Finally, the fourth wagon of the freight train carrying a shipping container, hits the second freight locomotive 120-012 and then comes to a standstill. On the next page (Figure 26), a set of pictures extracted from an animated sequence proposes an overall view of the collisions with their timestamps: image 2 showing the 1st impact, image 4 the 2nd impact and images 5 and 6 the movement till standstill.

Figure 26. Overall view of the simulated accident mechanism with the timestamps: image 2 showing the 1st impact, image 4 the 2nd impact and images 5 and 6 the movement till standstill.

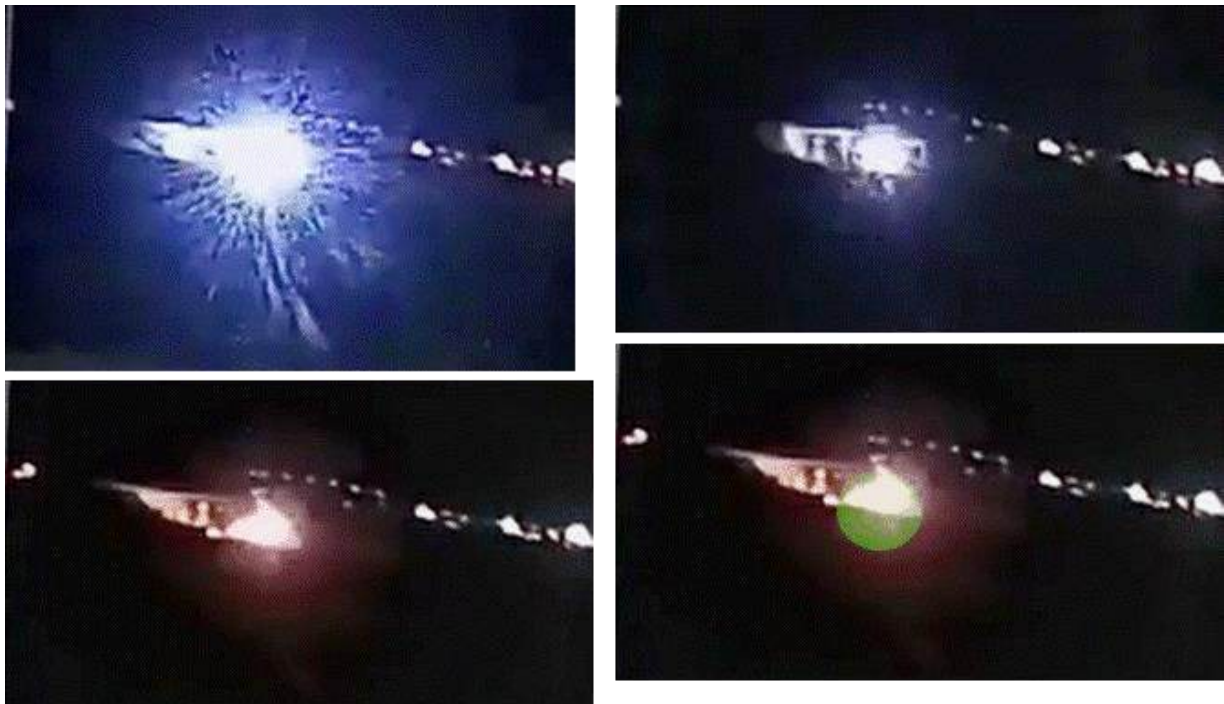
- 146 A first stage that can be observed, the ignition and creation of a fireball, starts at approximately 0.6 seconds after the initial contact between the locomotives of the two trains, when a first electric arc is being recorded on video. A short circuit is created with a bright flash due to the electric arc; and another 2 flashes appear rapidly after, each approximately 0.1 second apart. These 3 bright flashes stop after a total duration of about 0.3 seconds, which is consistent with the expected timing of the tripping of the automatic overload protection that was (manually) recorded at the power control station that remotely monitors all data at Thessaloniki.

Figure 27. First stage, arc flash and ignition. The green circle shows the theoretical expansion radius of the initial deflagration.

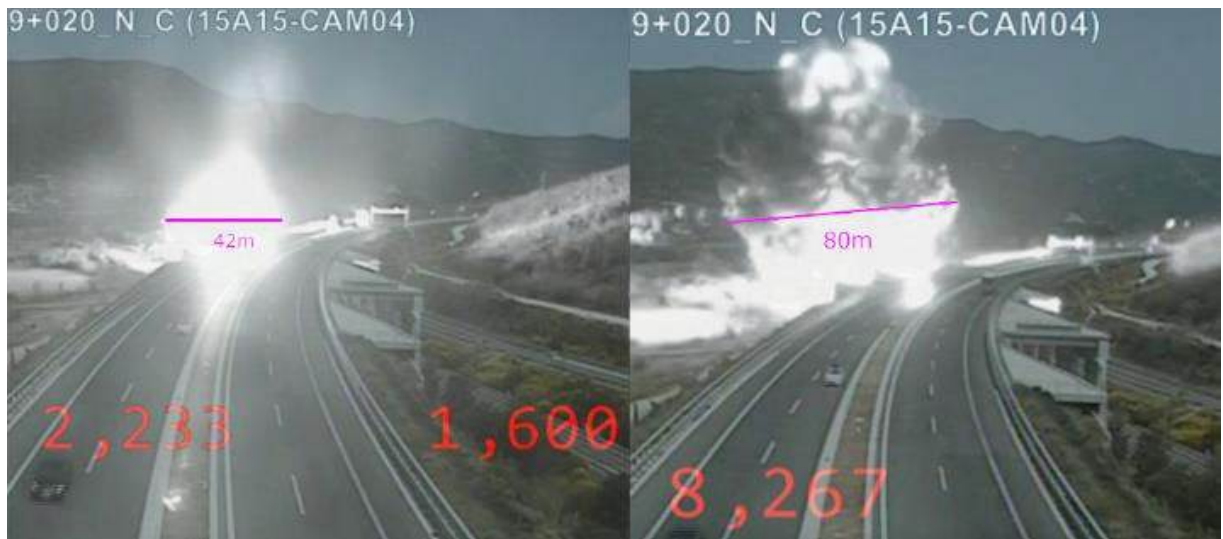
- 147 At the same time, the catenary lines themselves (both lines, one for each direction of travel) have been ripped off due to the collision, but the power was already cut within 0.2-0.3 seconds of the short circuit. Approximately 0.3 seconds after the end of the arc flashes, a fireball starts forming from the ground level and very rapidly expands upwards to a size of approximately 42 meters in diameter, which burns for approximately 2 seconds.
- 148 At approximately 2 seconds after the initial ignition, a second stage starts, when a new fire plume can be observed, moving northbound, away from the 1st stage fireball. This new fire plume is feeding the original fireball until it grows to almost double the size (80 meters) at approximately 4 seconds after ignition (Figure 28, Figure 29, Figure 30).

Figure 28. First (left) and second stage (right) of the fireball.

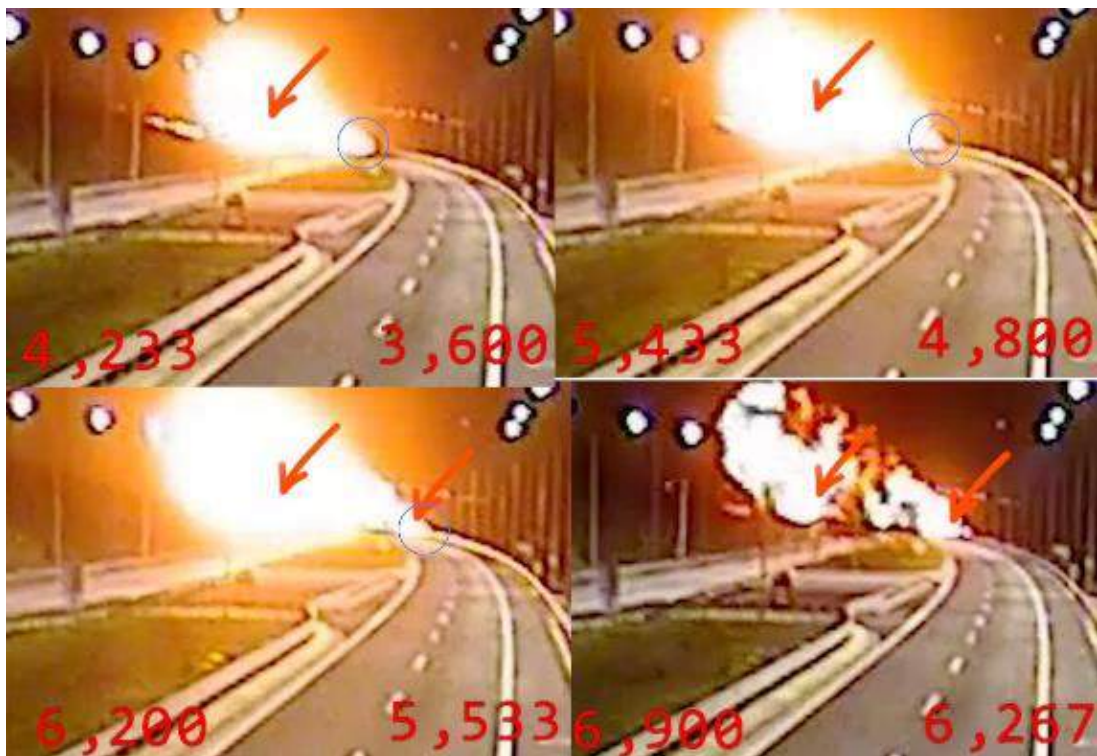
Figure 29. Second stage, fireball (left side of pictures) and fire plume (right side of the pictures)

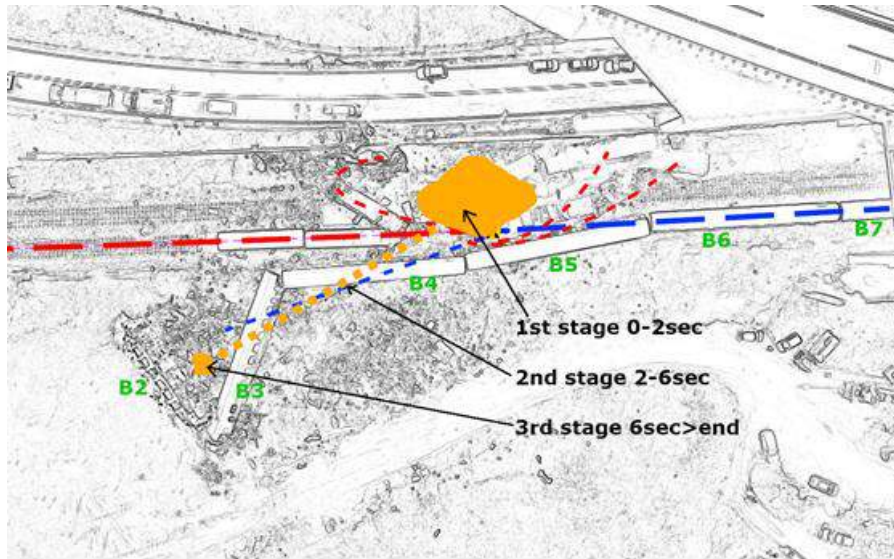
Figure 30. Clarification of the sequence with its timing.

- 439 As described before (3.9.3), observing the course of the fire gives rise to making a distinction between 3 different stages (Figure 30, page 47):

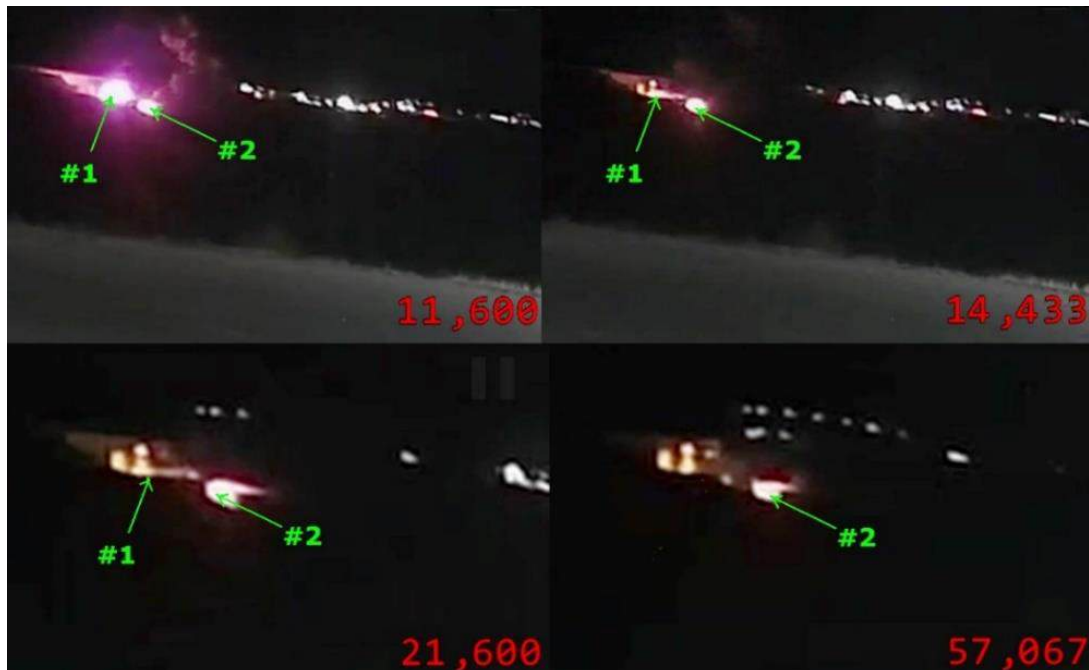
Figure 31. Pool fires #1 and #2

- 152 It is most likely that this pool fire #1 at some point heats up the silicone oil inside the transformer of the first freight locomotive 120-022 and smaller amounts of silicone oil having already spilled at the area and an additional amount draining from the cracks of the transformer case. This creates a smaller secondary fire of the silicone oil that can be observed in passenger videos 20-30 minutes after the collision and its location and size can be traced by the white residue (SiO₂) that indicates burning of silicone oil as it is observed at the area after the fire.

- 153 Pool fire #2 is burning with a very strong flame for at least 60 seconds before other combustible materials are added (flame color change), which made fire continue to burn stronger for at least 60 minutes after the collision. This fire has grown so strong in the first 30 minutes that the first firefighting effort at 00:02 (43 minutes after the start of the fire) from a single fire truck pumping water from the railway lines to the fire below, had minimal to negligible effect.

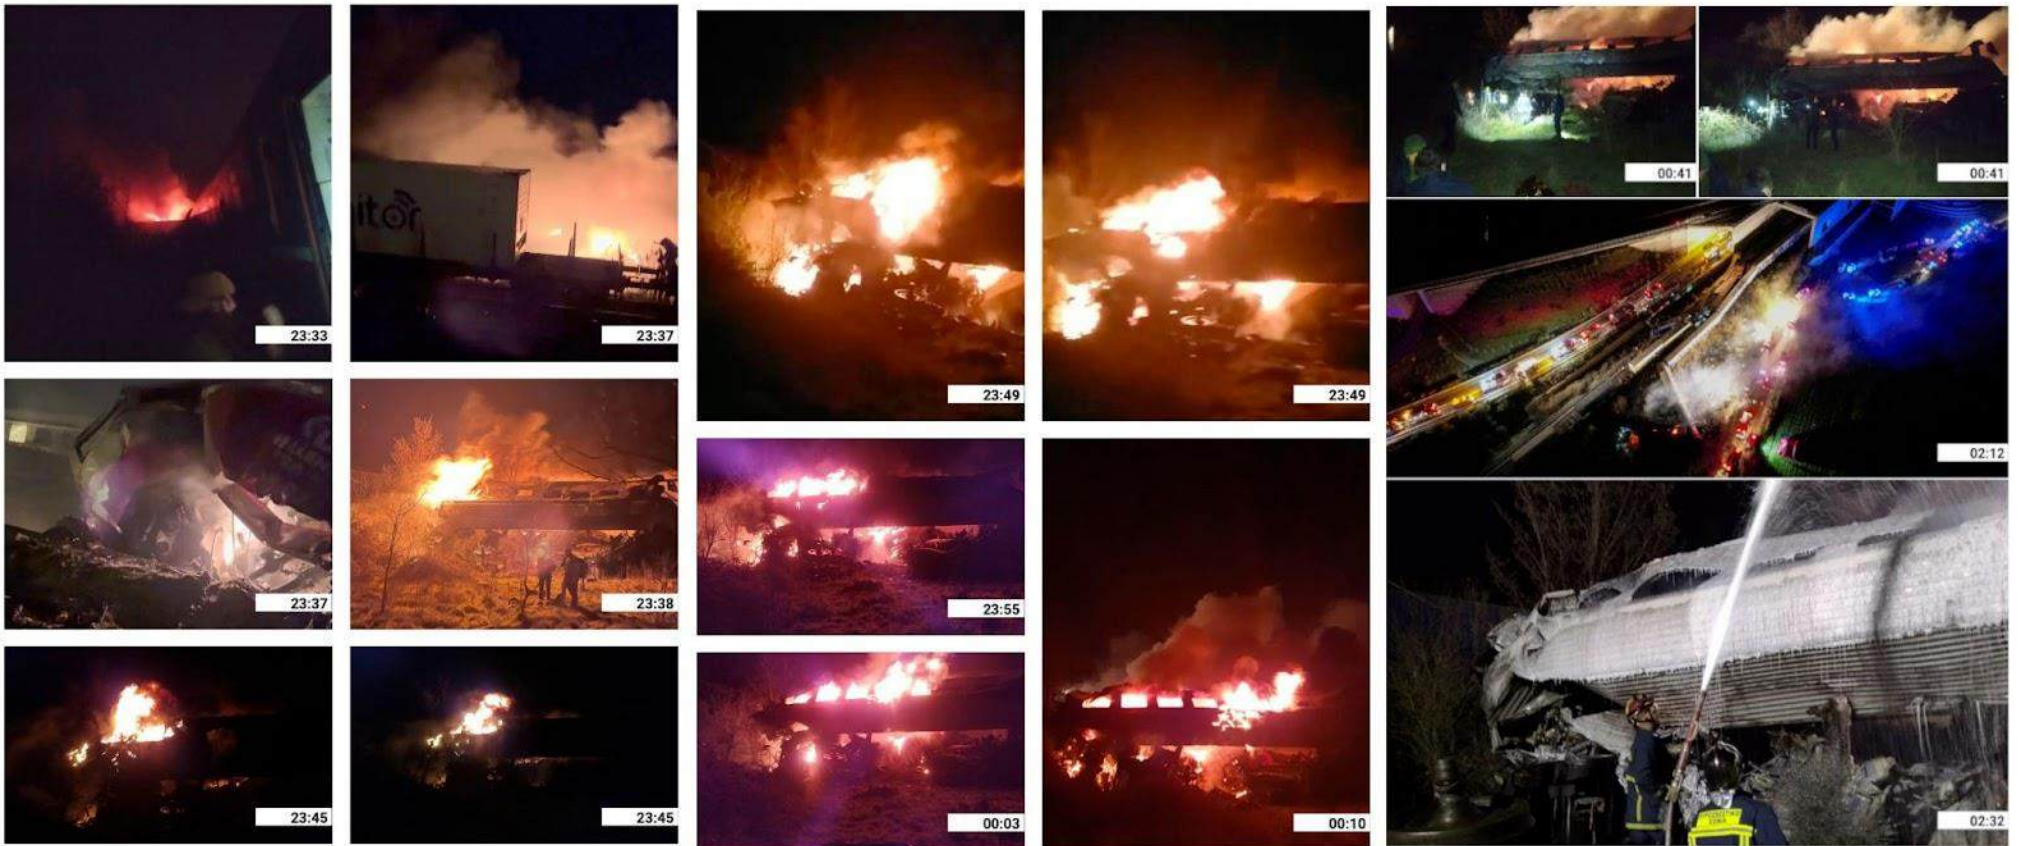
Figure 35. Photos of the fires development and their timestamp (source: EDAPO).

- 157 From the work of the EDAPO team of investigators, more details and a rebuild of the timeline of the fires are available, with timestamp on photos (Figure 35, next page). This timeline describes the development and decay of the fire (source: EDAPO).

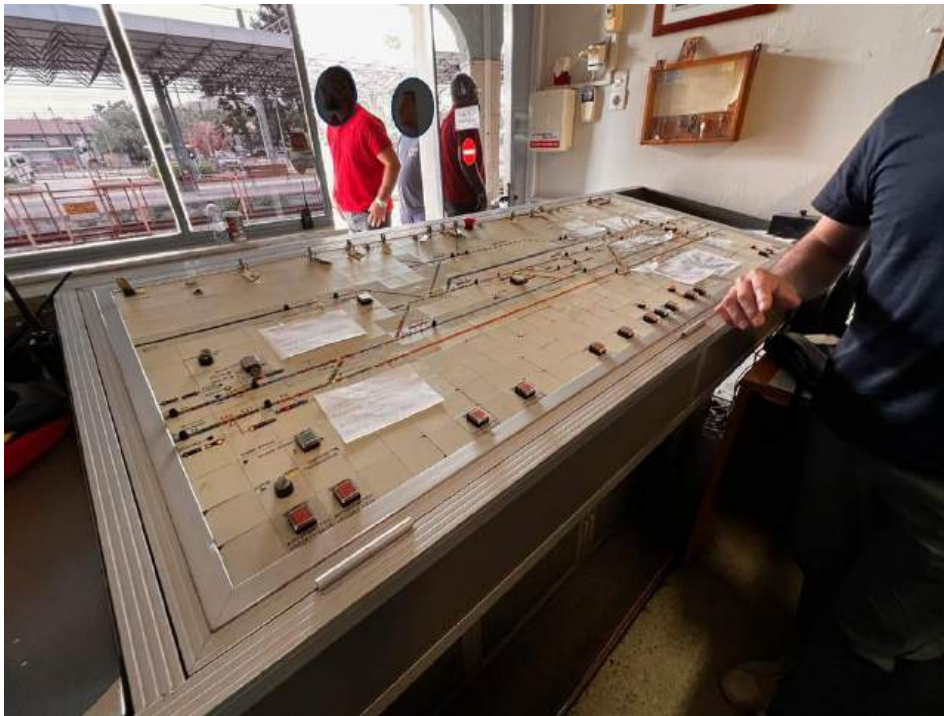
Figure 37. The control panel at Larissa Station

- 189 As it can be observed on the global photo of the control panel (Figure 37), it is a large area with many information and commands that cannot be considered at a glance. To pass from one mode to the other (manual mode to or from automated mode), the station masters must turn a numbered key (the number refers the number of the switch) on the top of the control panel (Figure 46), separately for each switch. The area where to read the switches numbers is small and partially hidden by the plastic and metal key rings (this point is further analysed in the chapter 4.2.2). In the actual practice of using these keys, as it has been explained and shown on site, at least two ways of manipulating them co-exist, one of them being indicative of lack of trust in the system and/or lack of experience (4.2.1.3).

- 243 The indications on the position of switched 118 are small indications, on two distinct positions, on a larger Control Panel (the information of the Figure 47 among the ones from the whole Figure 37).

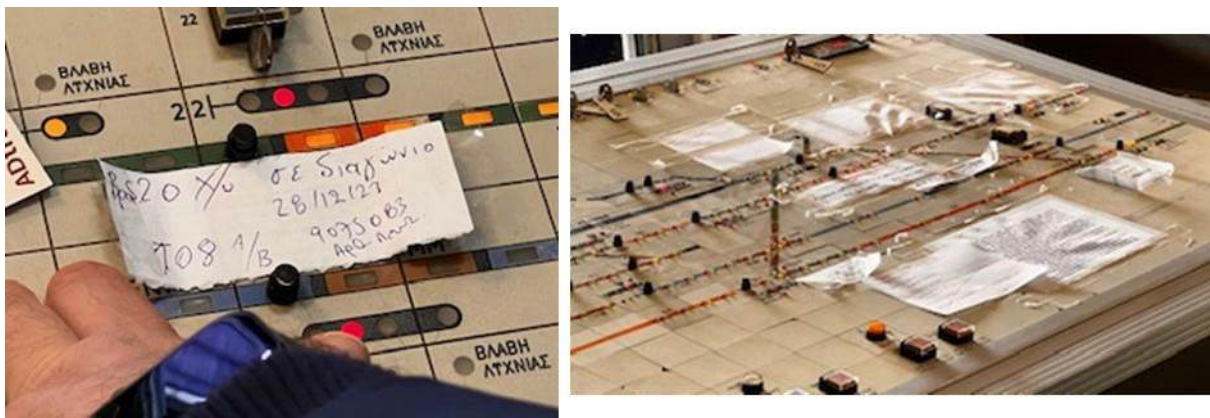
Figure 40. Useful pieces of information.

191 The Larissa control panel in the station masters' traffic control room, as well as others in actual operation (Figure 40), is supplemented by pieces of paper "taped" or just "laid" on the inclined panel. Their operational function is to remind the station masters of important local information on operational restrictions or degradations, some for a few hours, others for months (and even longer).

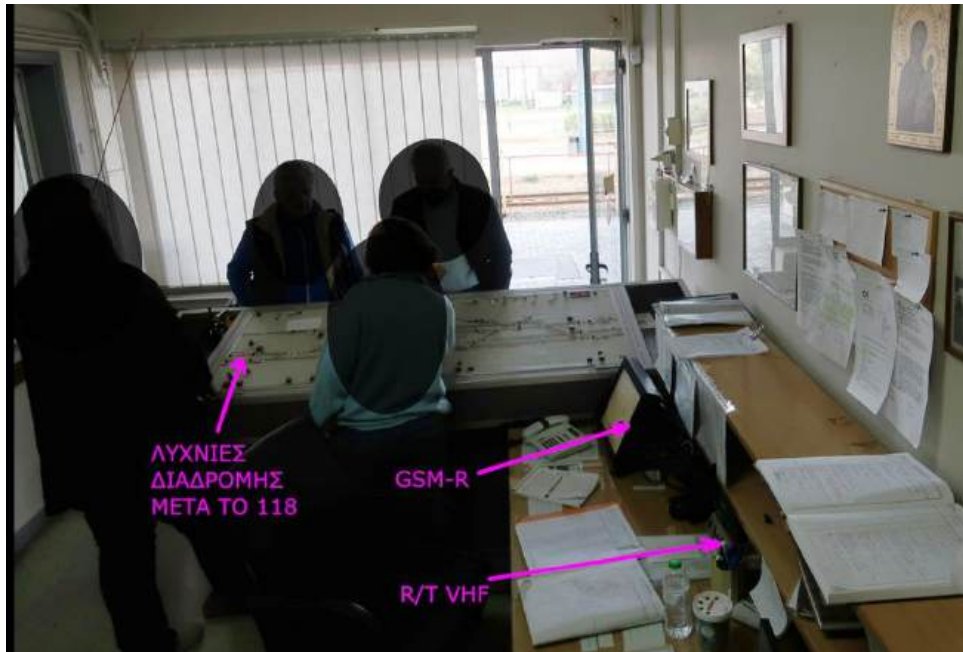
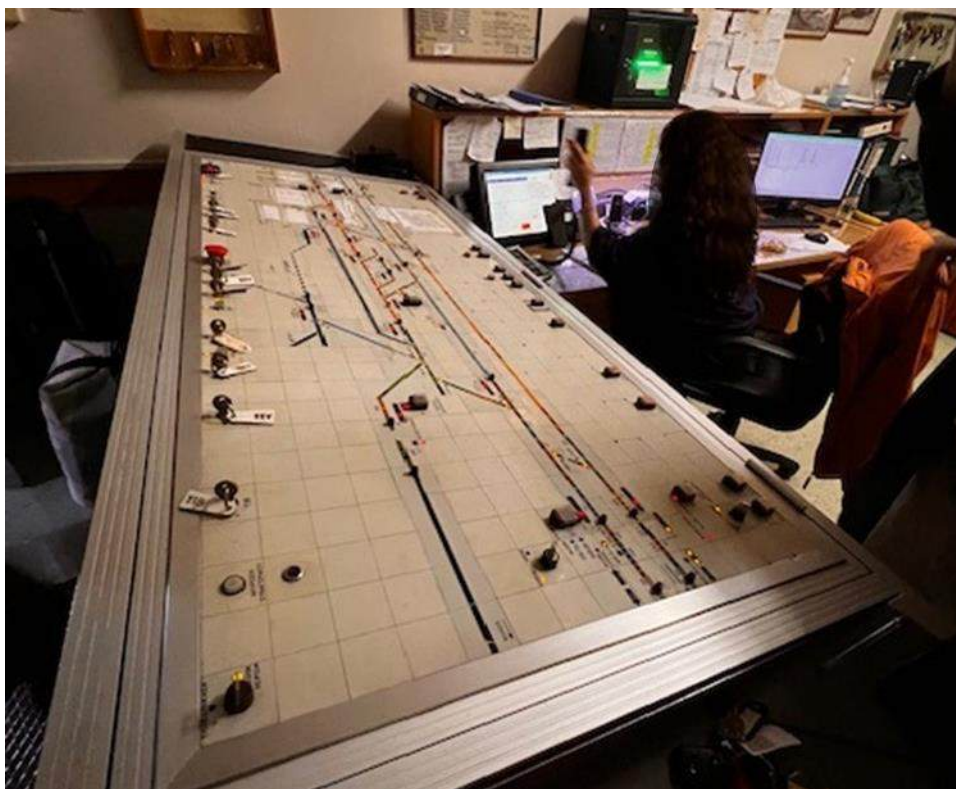
Figure 41. Positions of station masters when facing the control panel (above) and when communicating (below) in Larissa station.

192 Taken together with another source of influence, namely the numerous communications (as analysed in point 4.2.1.8), in the period of time just before and while the control panel was showing the passage of train IC-62 (240), it should be noted that this panel and the communications area are organised and physically positioned in a way that makes it very difficult to perform both tasks at the same moment. In morning and afternoon shifts these tasks are performed by two station masters in order to avoid excessive workload. When you are concentrating on communications, you are turned sideways in relation to the control panel and the LEDs that are lit in this case are behind you (Figure 41. Positions of station masters when facing the control panel (above) and when

193). This directly, logically and naturally explains how Larissa's station master did not 'see' or 'look', and therefore did not 'detect' the train's passage towards the descending track (4.2.2). During the investigation, 2 other situations were identified by the investigation team: one in which the station masters had adapted it and added a desk just in front of the control panel (Figure 42), and the other one, in Athens, when a Station Manager reported this as an issue and their manager made the situation more adapted.

- 245 Furthermore, the way the communication means (VHF console, GSM-R and telephone) are positioned on the right of the control panel and at a lower level (Figure 41). This means that, when occupied with whatever communication and logically directed towards the used means of communication, the indications related to the position of switches 118 and the departure of train IC-62 were situated behind the left shoulder of the station master in the left bottom corner of the control panel and so in practice invisible (192).

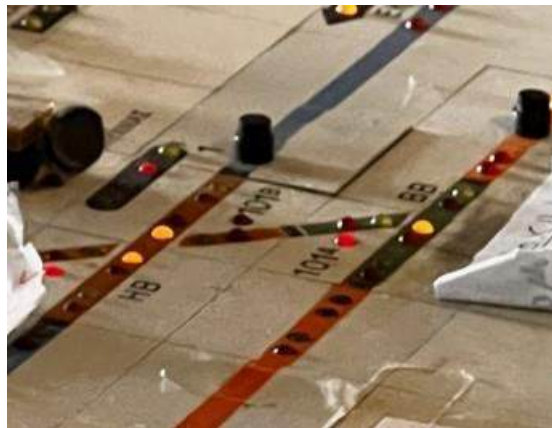
Figure 43. Switches 101A/B

- 214 Due to a problem with the overhead line that occurred earlier that day, traffic between the station of Paleofarsalo and Larissa was operated on a single line (92). This requires additional attention as well as specific communication between both station masters. Furthermore, this also requires an additional action for the trains that enter Larissa from Paleofarsalo from the descending track because the switch-combination 101 had to be turned into the bypass position to allow them onto track 2 in Larissa station (Figure 43).

- 215 Due to technical problems the switch 101A could not be operated remotely (94, Figure 43), via the control panel. To be able to maneuver the switch in the desired position, the station master has to instruct the local switch operator who in turn has to walk towards the switches and fix them in the requested position with a physical intervention. The station master in Larissa instructed the local switch operator at 22:46 to position switches 101 in a bypass position, directly after being informed by the station master of Paleofarsalo that train IC-62 had left for Larissa. At 22:57, the switch operator informed that the activity was performed.

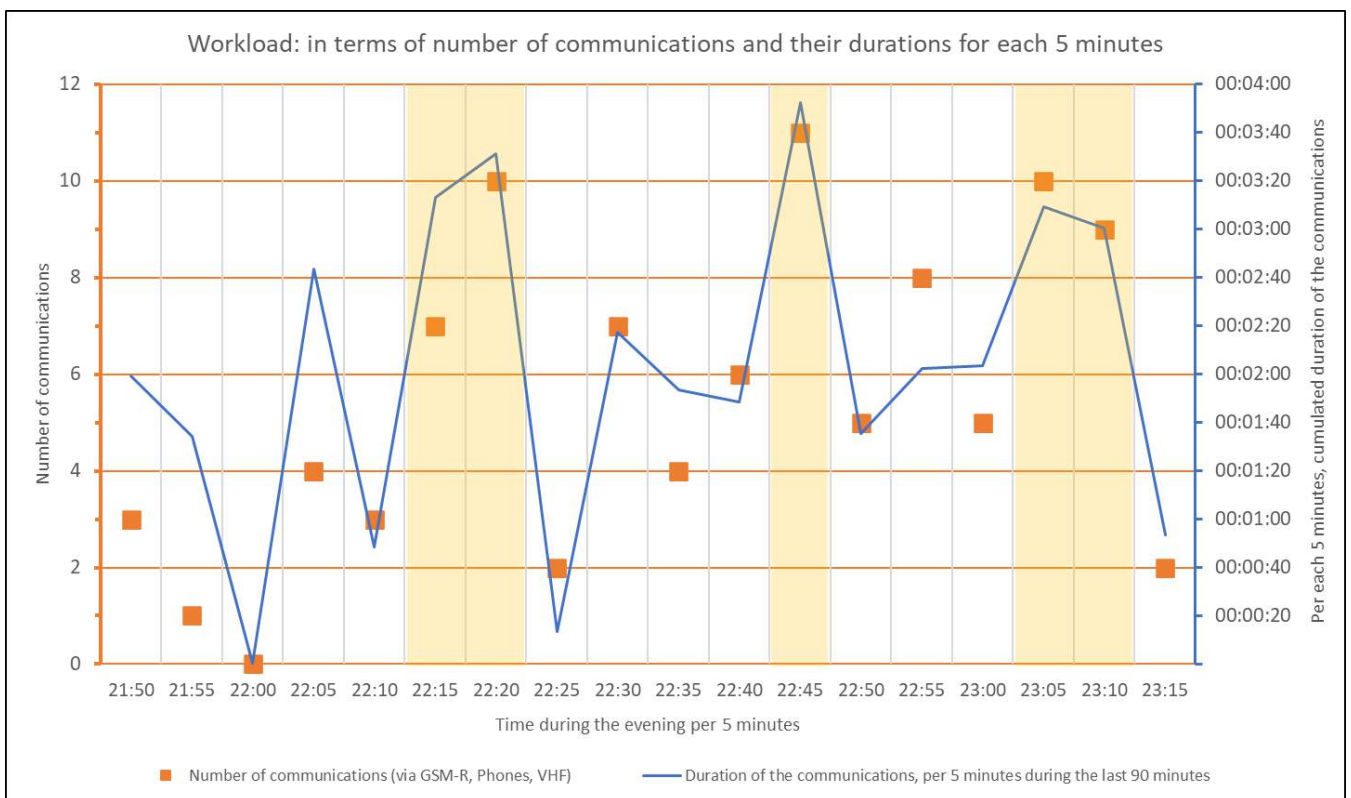
- 220 Analysis of only the communications, not even taking into account other tasks, indicate three peak periods (Figure 44) that appear to correspond with the consecutive mistakes made by the station master: setting the routes for respectively the train 2597 and IC-62 and not detecting the mistake with switch 118. This indicates that periods of too heavy workload, in particular for less experiences operators, can be a direct cause for errors, mistakes and routine violation, because there is “no-time-to-think” or one is “captured-by-the-flow-of-issues-to-contain”. This type of workload analysis, with results beyond human capabilities, shows the importance of integration human and organisational factors in risk management practices (4.2.80).

Figure 44. Factual analysis of the communication workload as a risk to be taken into account during HOF integration.

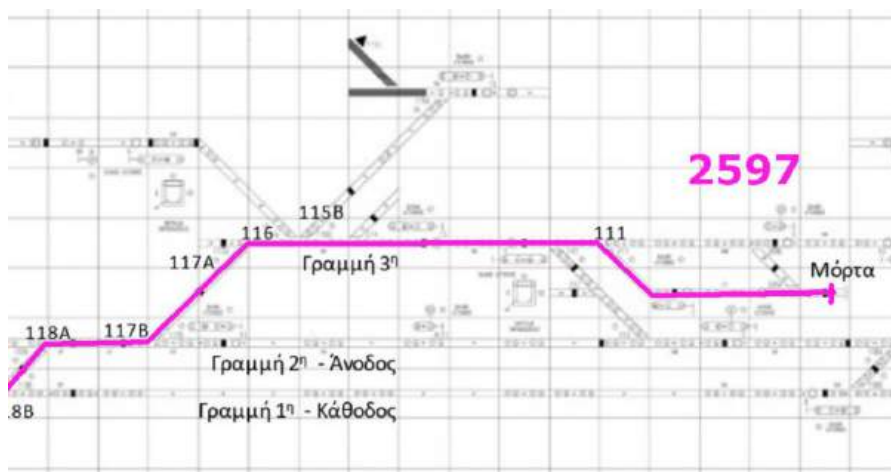
- 222 Approximately around 22:35, after having received a call from the train driver of train 2597 that he was approaching the station, the station master of Larissa manually set the route with the intention for train 2597 to enter Larissa station from the north and be guided to the dead-end track between tracks 2 and 3.
- 223 This would require the setting of switches 118A/B, 117 A/B, 116, 115B and 111 to be turned in the adequate position (Figure 45). Note that this is also the action that directed switches 118 in the bypass position. Before that, these switches were turned in the straightforward position at 22:12 for the entry of train IC-63. From the recorded actions on the control panel, it can be seen that this was the last time before the departure of train IC-62 that the switches 118 were manipulated through automatic route setting.

Figure 45. The route for the entry of train 2597.

When manually setting the route for the entry of train 2597, the station master of Larissa forgot to turn the switches 116 and 115B in the correct position. On other occasions these switches would have been in the right position after the entry and acceptance of train 2575 from Volos on track 3. Earlier in the evening, on the 28/02 this train 2575 was positioned on track 6 at 22:10 by the station master of the afternoon shift because track 3 was occupied with train 2594 that had been brought back to the station at 21:30 after traction problems arose on its way to Neoi Poroi (93).

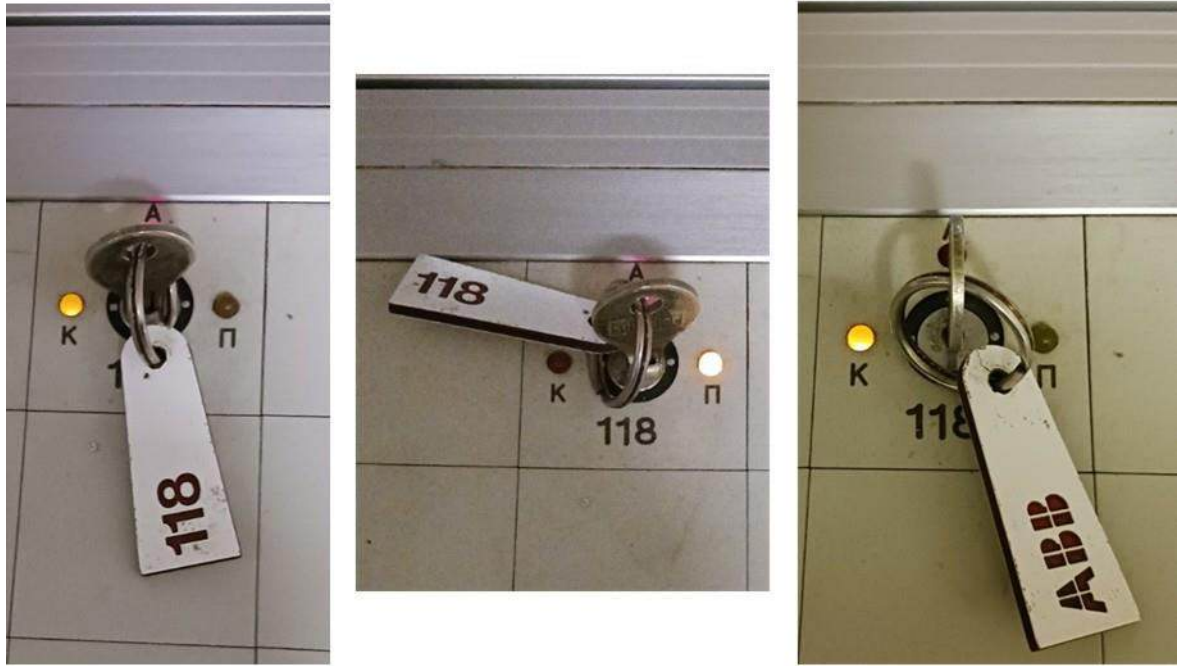
- 236 On the upper part of the control panel, there are three-position keys that are numbered according to the electrically driven switch they handle. These keys are used for the independent, manual control of any electrically driven switch. Turning the key from the central position by 90 degrees counterclockwise will command the switches to move to the "main" position (indication "K"). Similarly, by turning the key 90 degrees with the clock, the switches are commanded to move to the "bypass" (indicator "Π") position. When there is a correspondence between the physical position of the switches and their control key, the yellow light diode for the indicated position of the switches is lit steadily. Above the key of each switch, there is also a red light diode, in the central position marked "A". This is the position the key should be put in to allow for "automatically setting" the routes. (Figure 46).

Figure 46. Detail of the three-position key for handling switches 118 on the Larissa Control Panel.

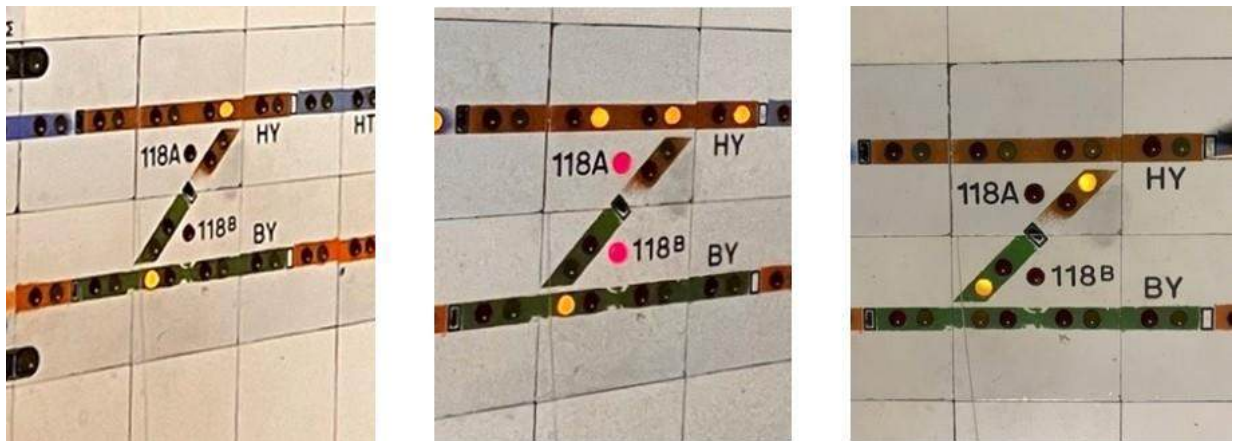
237 Switches are indicated on the Control Panel by the intersection of the lines showing the railway lines. Each switch is marked with a number and a letter if two switches have the same number. There are two yellow lights that indicate the position of the switch position in "main" or "bypass"(Figure 47). By setting the route, the lights in the area of the switches light up, as a combination of the light at the entrance of the switch and either the "main" or "bypass" path.

Figure 47. Detail of the switches 118 on the Larissa Control Panel (main-moving-bypass).
