Rail Accident Report

Head-on collision between a passenger train and a freight train
in Tempi, 28 February 2023

RL01-2025, 27 February 2025

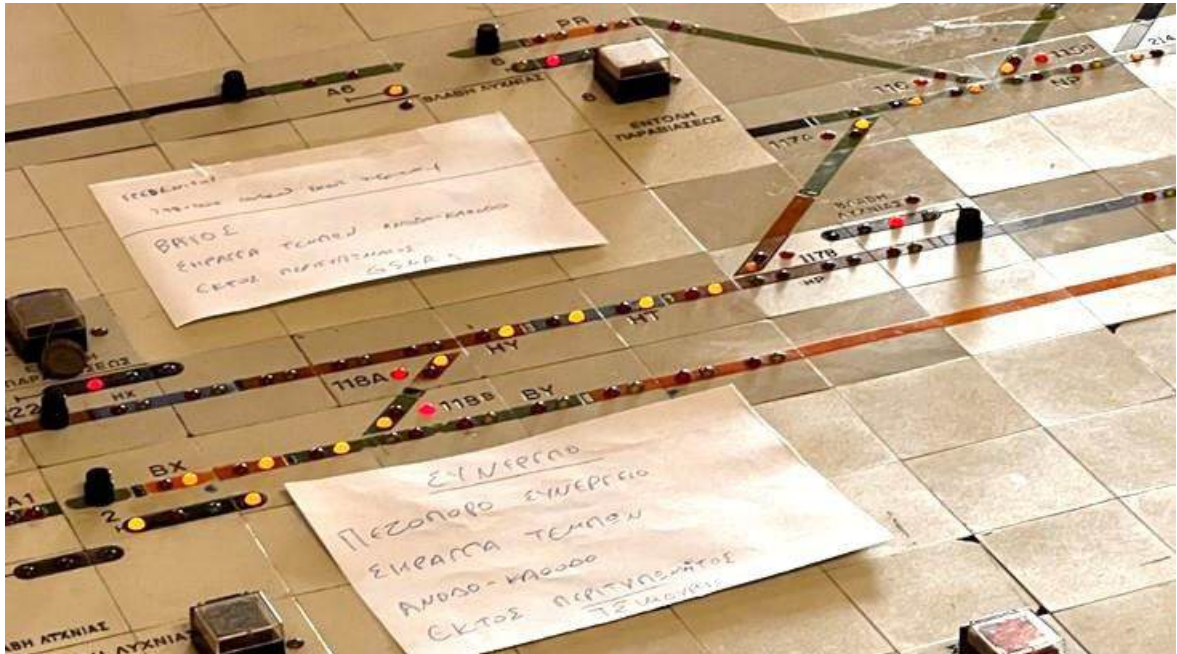
238 Lines on which the presence of a train is detected by track circuits or axle counters are displayed on the Control Panel in a sequence of colours delimiting the track circuit or the area controlled by each axle counter. The main lines use a sequence of colours orange/green for the ascending and blue/brown for the descending tracks (Figure 48). Within the coloured lines representing detection circuits photodiodes are placed that light up to give information to the panel operator. Lighting the yellow light on a track circuit means that a train has been "routed" to cross the section of line which is bright. The yellow light remain bright until the train reaches the circuit, when they are switched off and replaced by a group of red lights, which means that there is a train in the specific detection circuit.

Figure 48. Detail of the Larissa Control Panel with a route set to cross a switch in a bypass position.

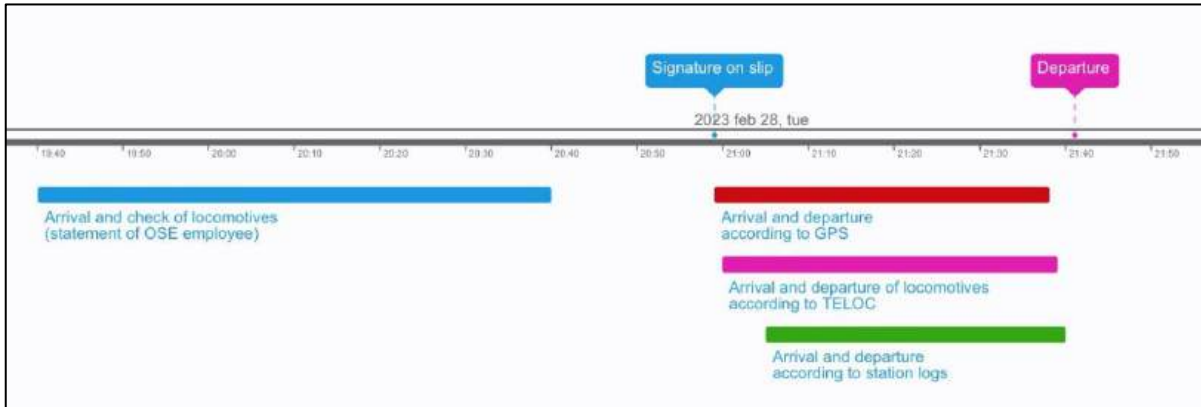
Figure 51. Timeline of the movement of the freight train 63503

and arriving at Thessaloniki Freight Station and then remaining stationary for approximately 25 minutes (from 21:15 until 21:40).

284 The same timeline of events is supported by GPS data of the movement of the locomotives as provided by Hellenic Train. A similar timeline is supported also by the logbook of the station master at Thessaloniki Freight Station (locomotives arrive at 21:05, test finished by 21:35 and train leaving at 21:40).

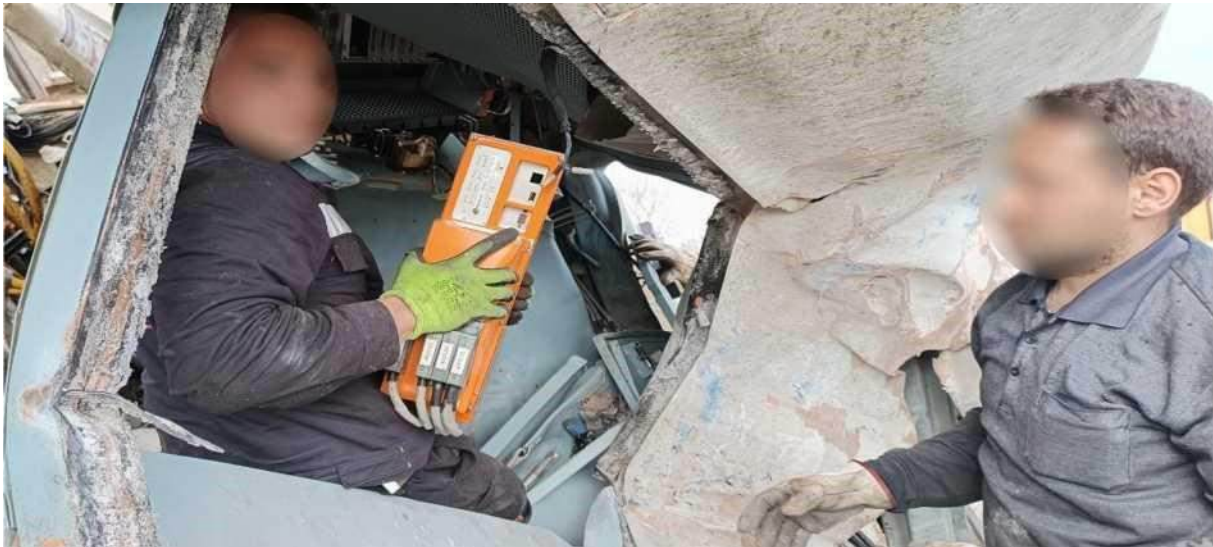
Figure 54. On board TELOC data recorder, train 63503, locomotive 120-022, retrieved by judicial experts on the 05.03.2023.

416 At the moment of the first impact, as registered by the on board TELOC data recorder that was retrieved from the accident site, the speed of train 63503 was 89.91 km/h. This is within the speed limit of 100 km/h for freight trains at this location (4.2.4). Since the train drivers of train 63503 could not possibly have identified the impending danger of the passenger train coming out of the tunnel earlier, emergency braking was activated only one second before the actual impact.

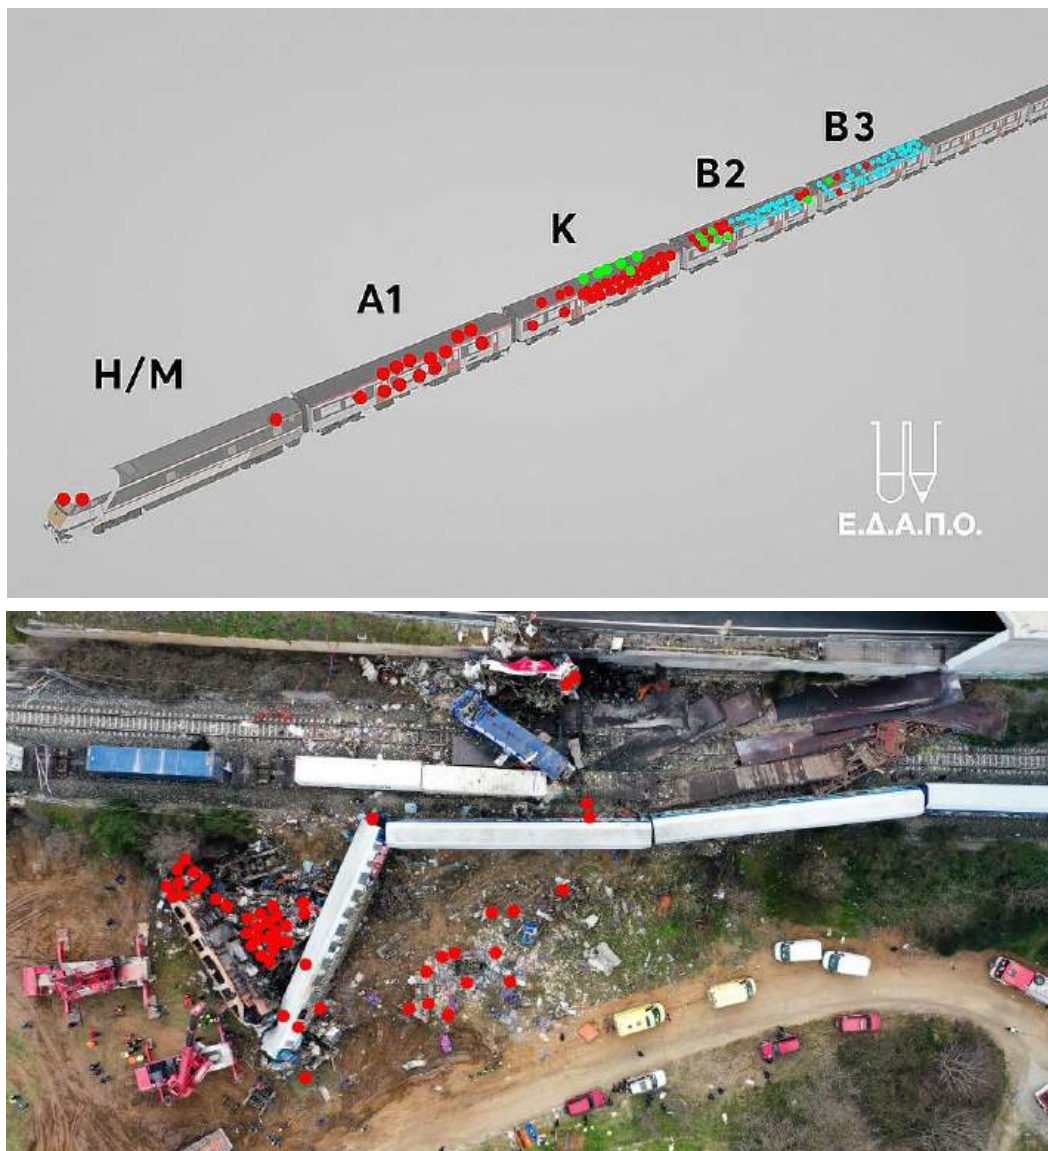
Figure 55. Initial and final estimated positions of fatalities, visualised on the scheme of the impacted part of the IC-62, and on-site.

- 423 The B3 coach of the passenger train was not subjected to heavy deceleration forces and was totally survivable, if not for secondary impacts from the B2 coach hitting its roof and a section of the locomotive hitting against the side of the B3 coach. There were 2 casualties that both suffered severe head and spinal trauma due to impact by heavy debris entering through the side windows. Both casualties were killed instantly without any chance of survival, given the unlucky position they happened to be at (other passengers sitting next to them were practically unharmed). And 5 injured victims were ejected during the crash or jumped from a height to exit the carriage.

- 445 Of the total length of the passenger train IC-62, the only parts that were totally consumed by the fire were the rear part of the Restaurant Car (letter K on the drawing, Figure 55, page 91) and the B2 passenger coach.

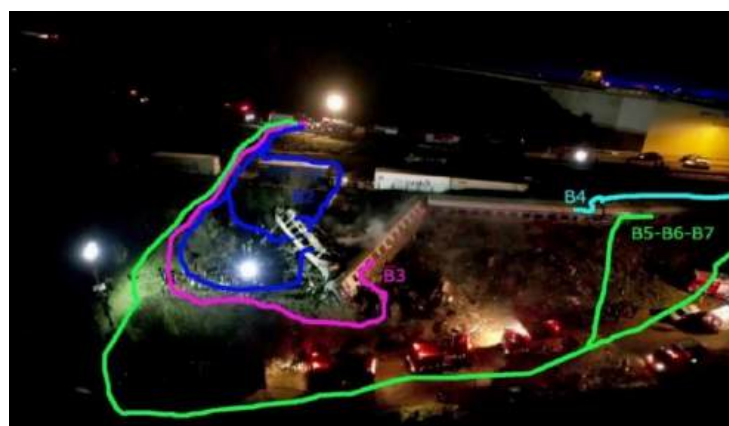
Figure 56. Self-evacuation paths of passengers before emergency services arrived at the scene.

- 427 Passengers from coaches B4 to B7 managed to operate the emergency handles of the doors and open the doors to self-evacuate successfully. On the B3 coach, access to the front doors was limited due to parts of the roof collapsing and blocking the narrow passage to the door. Passengers chose to break a window on the left side and climb down from there in order to self-evacuate. The Fire Service used the same window in order to enter and evacuate 3 casualties and 3 injured passengers who were trapped and needed mechanical tools to release them.

- 428 At least two passengers sustained serious injuries (bone fractures and dislocations) during evacuation: 1 female passenger jumped from the top row of windows of the B2 coach and was injured by falling on debris below (subsequent passengers jumping from the same window avoided this by throwing their luggage to land on top of softer surface) and 1 male passenger who was the first to jump from the B3 coach front left window, sustained serious injuries by falling on debris below (subsequent passengers evacuating from the same window took care to climb down carefully in order to avoid injury). An unknown number of passengers were reportedly lightly injured during evacuation, mostly in a similar way.

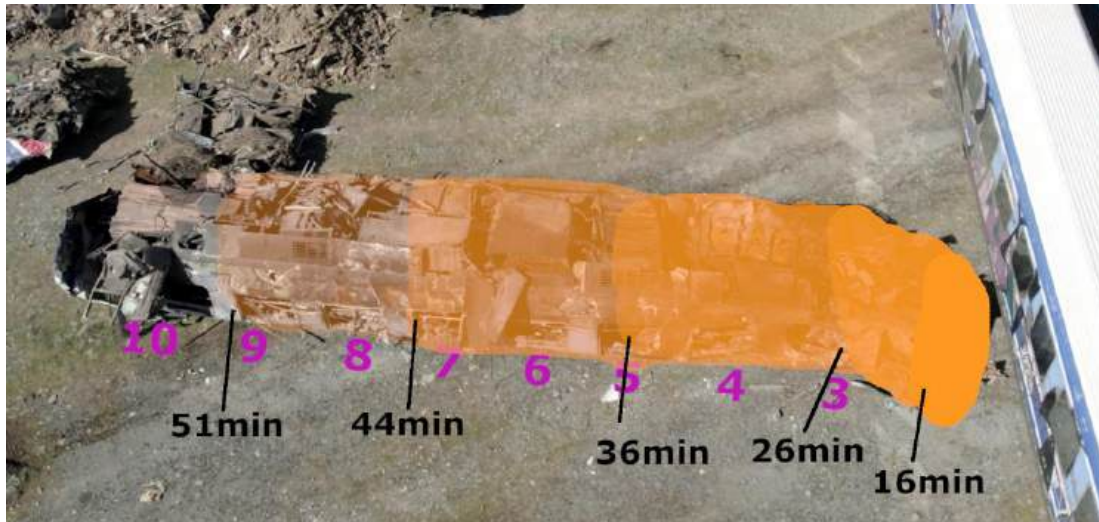
Figure 57. Progression of the fire in the B2 coach (from right to left, in minutes). (Source: EDAPO)

449 This secondary fire of the B2 coach started from the bottom part and in due course (around 23:35) went up to the front part of the B2 coach and consumed the entire length of it, without any active firefighting until the fire reached the end of the wagon and started to threaten the B3 wagon (Figure 57). By 23:38 or after about 16-20 min, the front of the B2 wagon had started to burn with very strong flames. After that stage, this fire did not show any abnormal or unexpected speed and flame strength (Figure 57). The slow speed of this fire is consistent with a fire that feeds on the upholstery, the fittings and the construction materials of the carriage itself, without the obvious presence of any accelerant. Without any firefighting (either active or automatic), the fire took its course and burned every flammable material available. After about 35-40 min, the fire had advanced further along the coach and by 00:00 it had passed midway through the available length. By 00:40, the fire had consumed the entire length of the B2 and had started to self-extinguish, likely having nothing else to burn.

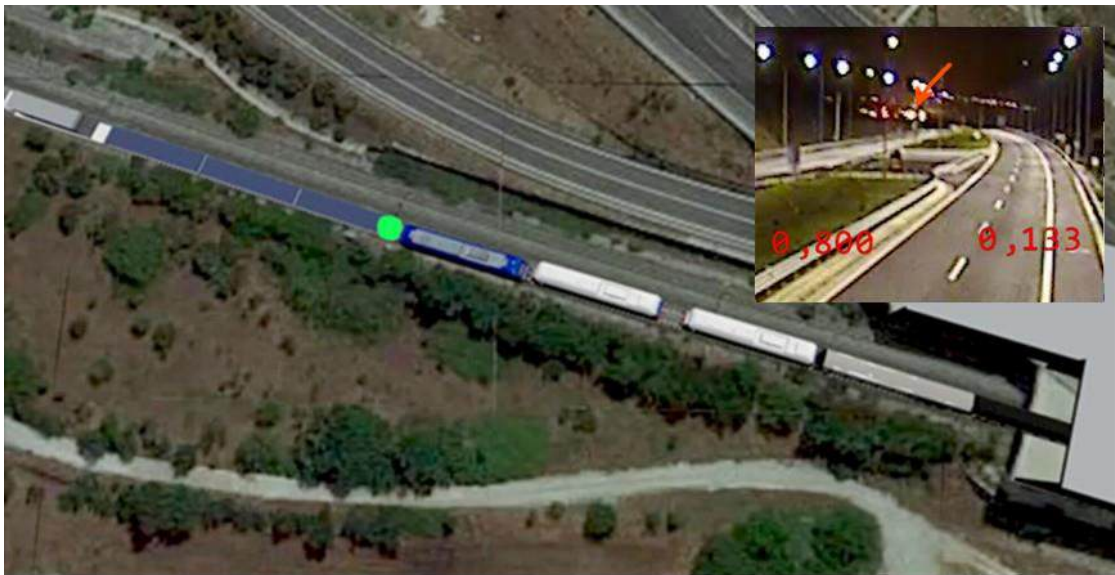
Figure 58. Estimated point of initial ignition.

- 456 The deflagration is ignited approximately 0.3 seconds after observing the electric arc, and it starts at ground level (note the hemispherical shape) with the huge amount of sparks from the emergency brakes locking the wheels of both trains (consistent with victims' testimonies) being the most probable source of ignition.

- 457 A comparison between the viewing angles of the three available cameras with an effort (via triangulation coupled with kinematic analysis of the crash sequence) to locate the exact point of initial ignition shows a probable point of ignition in the area between the 2nd locomotive of the 63603 freight train and the first flatbed carriage of the same train (Figure 58).

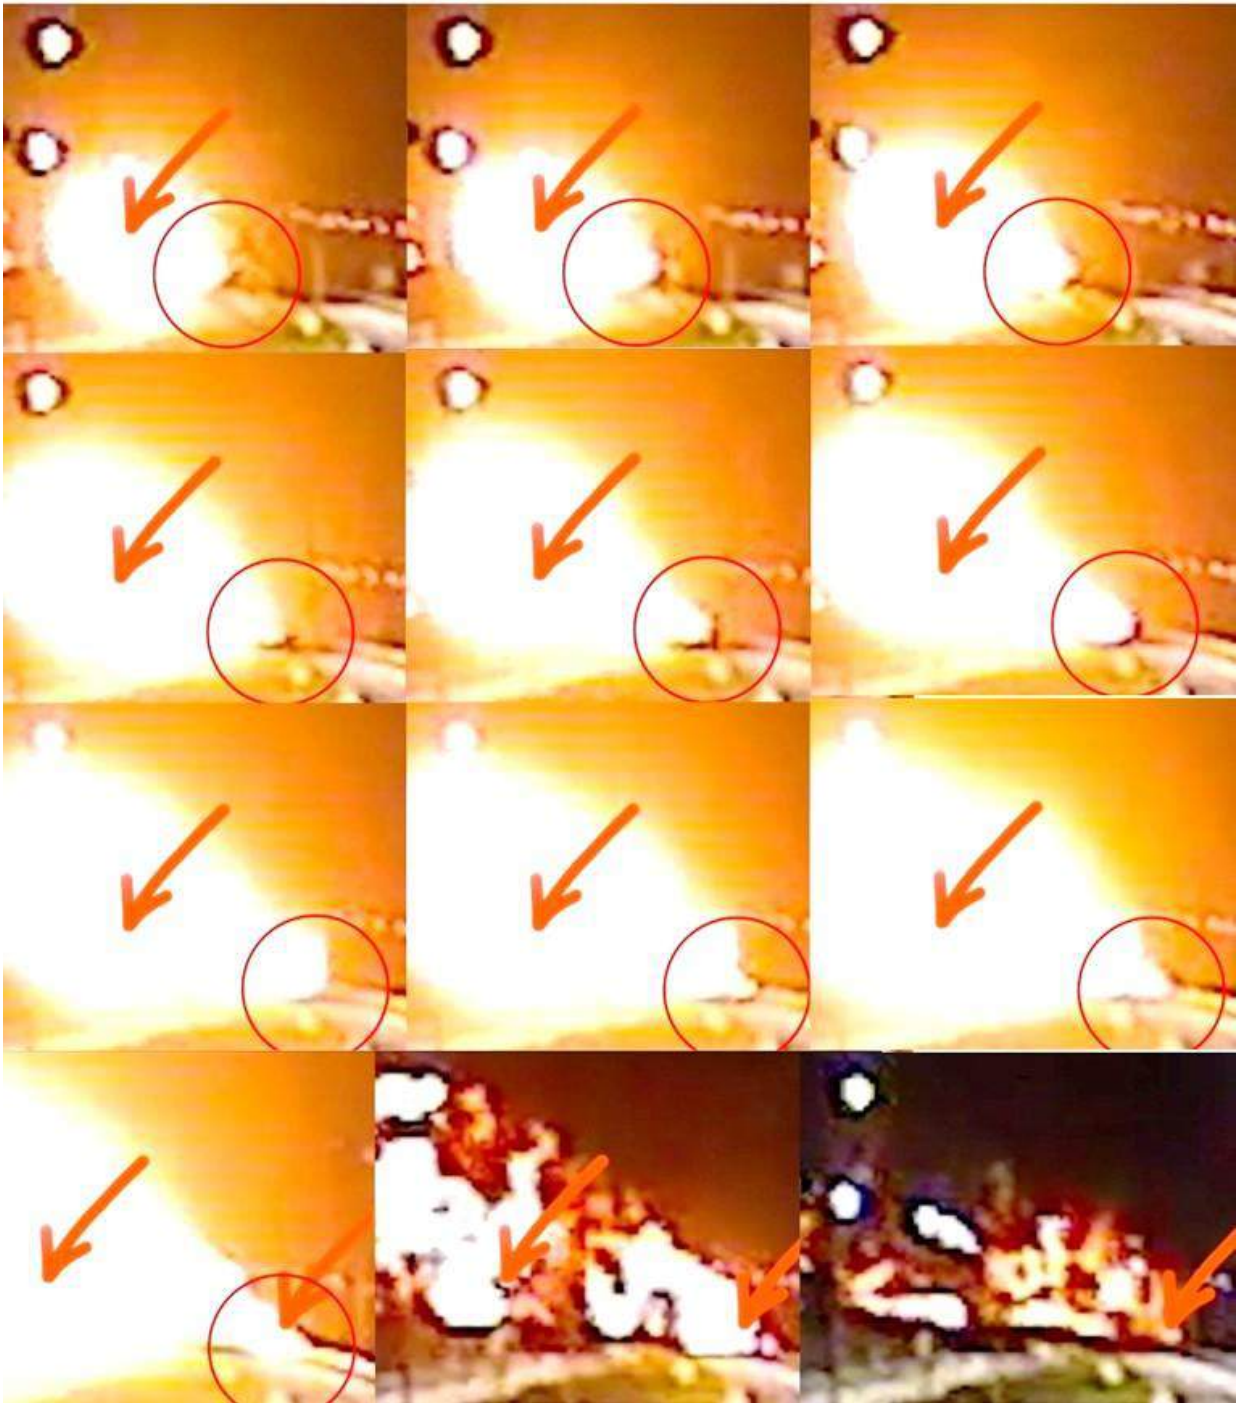
Figure 59. The sequence of the fire from the point of collision to the final stage.

- 458 The following sequence of images (frames from the Aegean Motorway video) starts at 2 seconds after the initial deflagration that started at the place indicated by the red arrow. As can be observed by these video frames, a dark irregular shape is moving in a northbound direction for a duration of approximately 4 seconds, during which time strong flames can be observed coming out. The distance covered was approximately 40 meters so this gives a mean speed of 10m/sec or 36kph for the carriage until it comes to a stop.

- 459 The shape of the initial deflagration and ensuing fireball is consistent with liquid volatile fuel and not with liquified gas, which would create a jet fire and not a fire plume. A jet fire is “a high temperature flame of burning fuel released under pressure in a particular orientation” meaning that a jet fire would have a different shape and random orientation (not only upwards). Further indication of this, is the existence of the secondary pool fires that continued to burn, and which could not be created by a gas. The very quick initial deflagration and the shape and lift of the “mushroom” form also point towards a volatile, liquid fuel (an oil fire would fall quickly to the ground).

- 461 The above frames from the Aegean Motorway video (Figure 59) do not allow to identify the dark irregular shape. To be able to identify this part of the passenger train that was making the fireball move to the north, evidence from the video that has recorded the event from the southern side ("Maliakos-Kleidi" camera), and other available videos collected by passengers a few minutes after the crash was correlated.

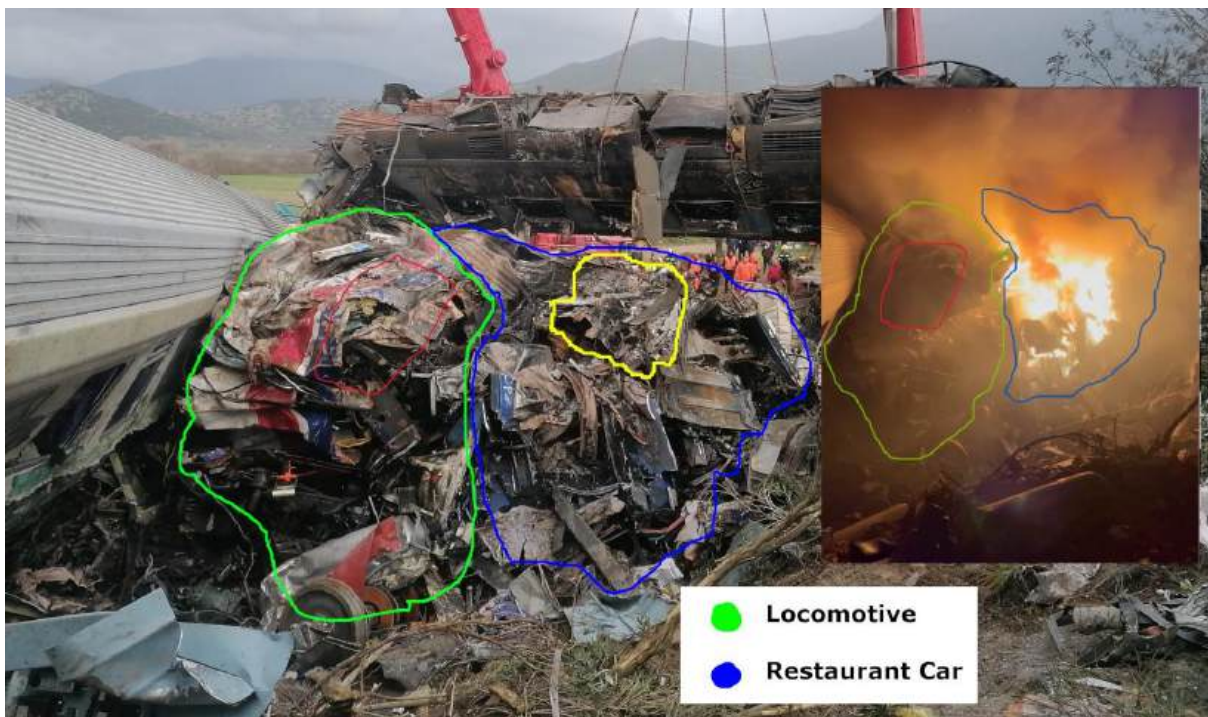
Figure 60. Restaurant burning next to the passenger train locomotive, with the position of the transformer in red.

- 462 The passenger videos show a very strong but very concentrated fire burning fiercely from the bottom of the Restaurant Car (color yellow added) while the remains of the passenger train locomotive (including the transformer filled with silicone oil) can be observed at a very close distance but clearly not on fire. This observation can be verified by the examination of the remains of the trains on the next day (Figure 60, Figure 61), where it is clear that the locomotive (color green added) is mechanically destroyed and, like the transformer (color red added), only has burn marks on one side, while the Restaurant Car (color blue added) is totally consumed by the fire.

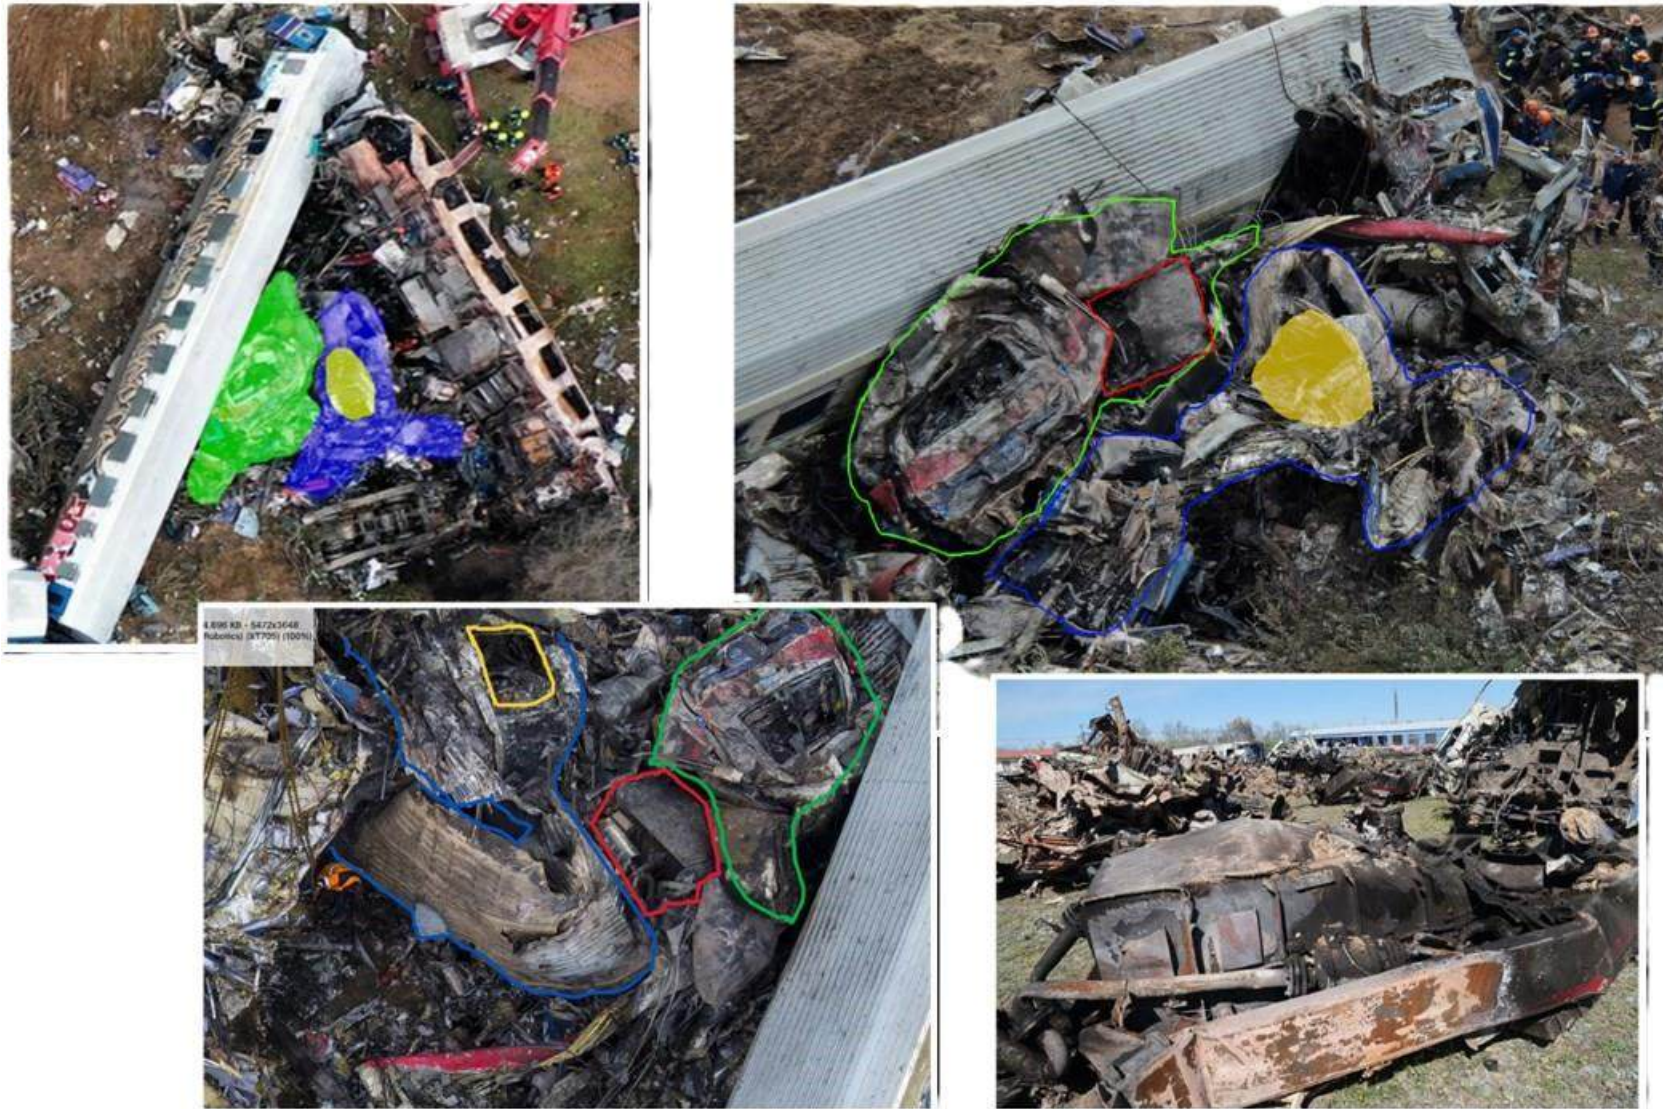
Figure 61. Further images of the location of the Restaurant Car, Passenger Locomotive and its transformer.

Figure 67. Large cracks of the transformer still attached under the 120-022 locomotive (Left). Bumps, folds, rips and large cracks of remaining locomotive transformer 120-023 (right), see also Figure 61.

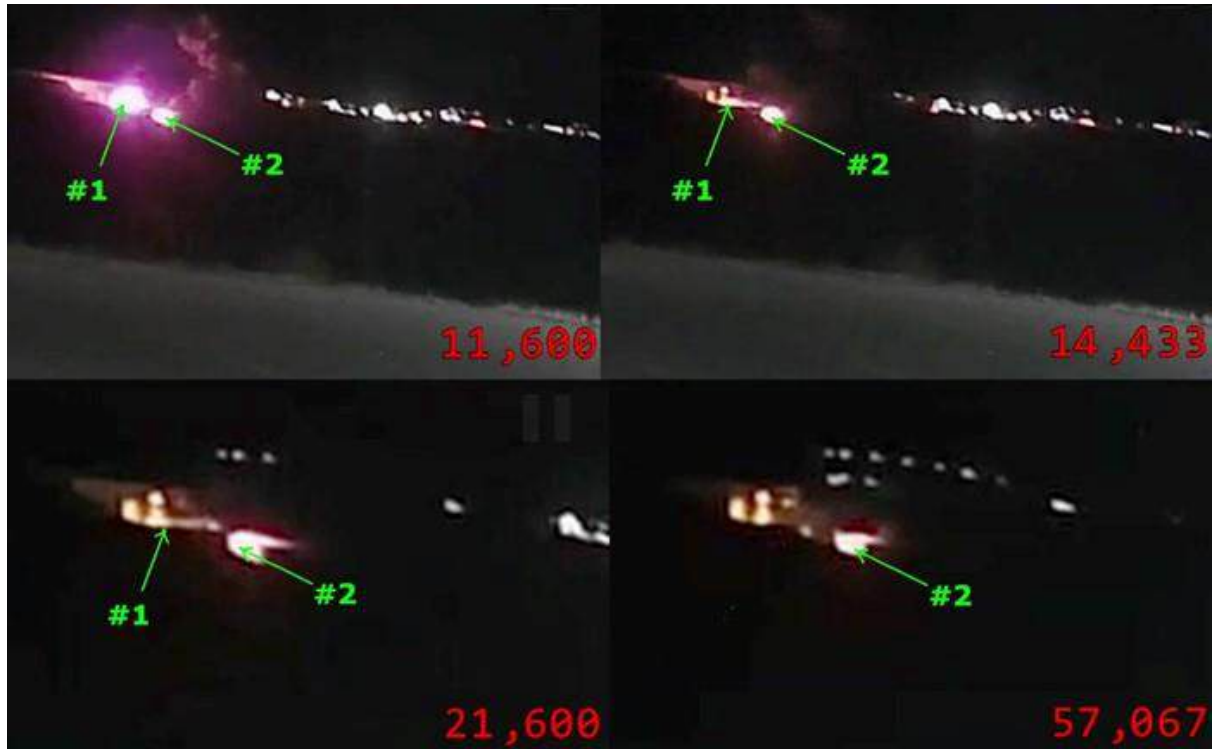
Figure 62. Fire plume moving into pool fire #2, as observed by the "Maliakos-Kleidi" camera.

463 By following this fire backwards in time, it is most likely that the fire that consumed the Restaurant Car is the same fire that has been recorded 4 minutes after the crash, burning from the bottom of the (crashed and bent in an S-shape) Restaurant Car (color yellow added). This is also the same fire that is observed from the "Maliakos-Kleidi" camera (Fig. Y), as an uninterrupted continuous movement from the fire plume (stage 2) to pool fire #2 (stage 3).

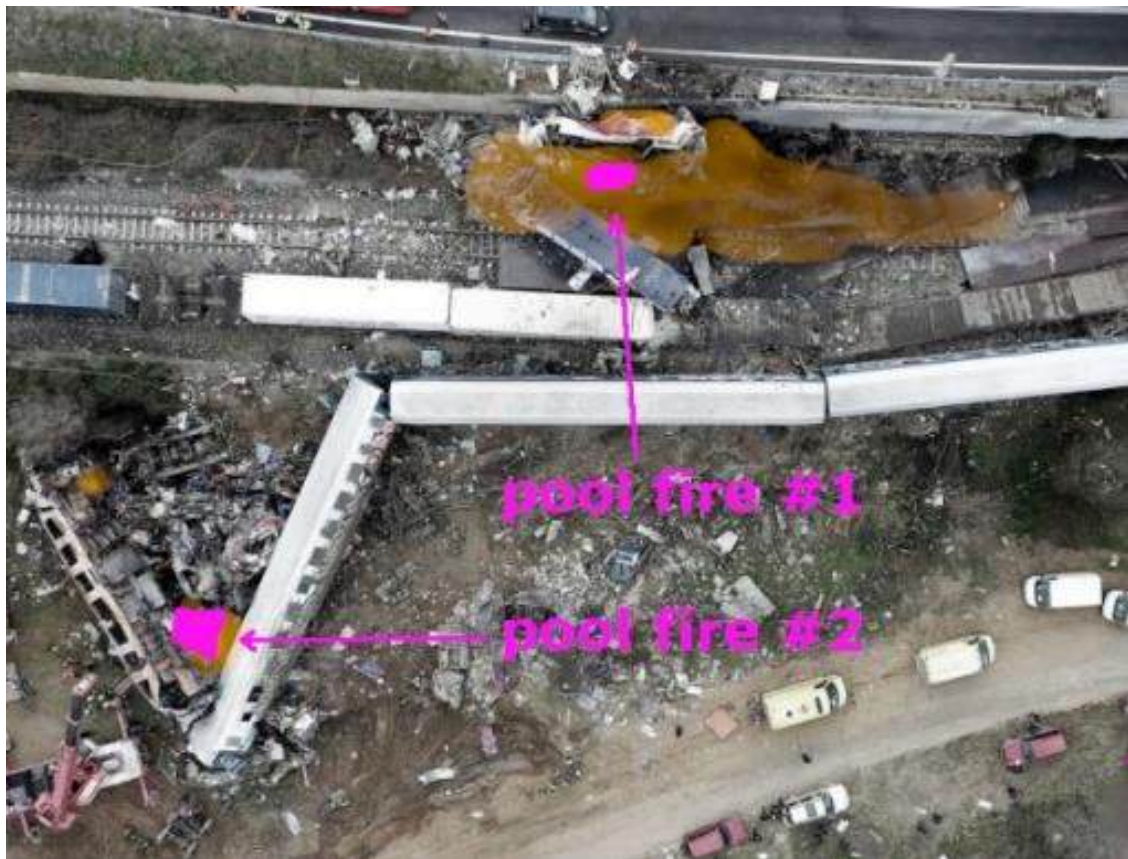
Figure 63. Location and approximate size of pool fires #1 and #2.

464 The two pool fires can be observed burning up any remaining fuel that was not consumed in the fireball. By comparing the geometry of the nighttime frames of video to the daylight images, it is confirmed that the two pool fires are located where fire evidence were found in the morning.

- 465 When following the logic of these observations, it is highly unlikely that the locomotive and its transformer filled with silicone oil played a primary role in the stage 2 fire plume and stage 3 pool fire #2.

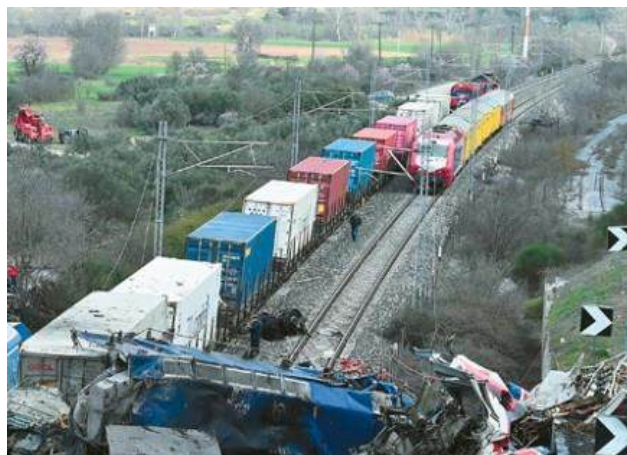
Figure 84. Positions 8)-15) The remaining platforms carrying 8 containers, undamaged and still sealed (or remained empty, of the 2 last ones), not derailed, stopped along the line and were driven away normally.

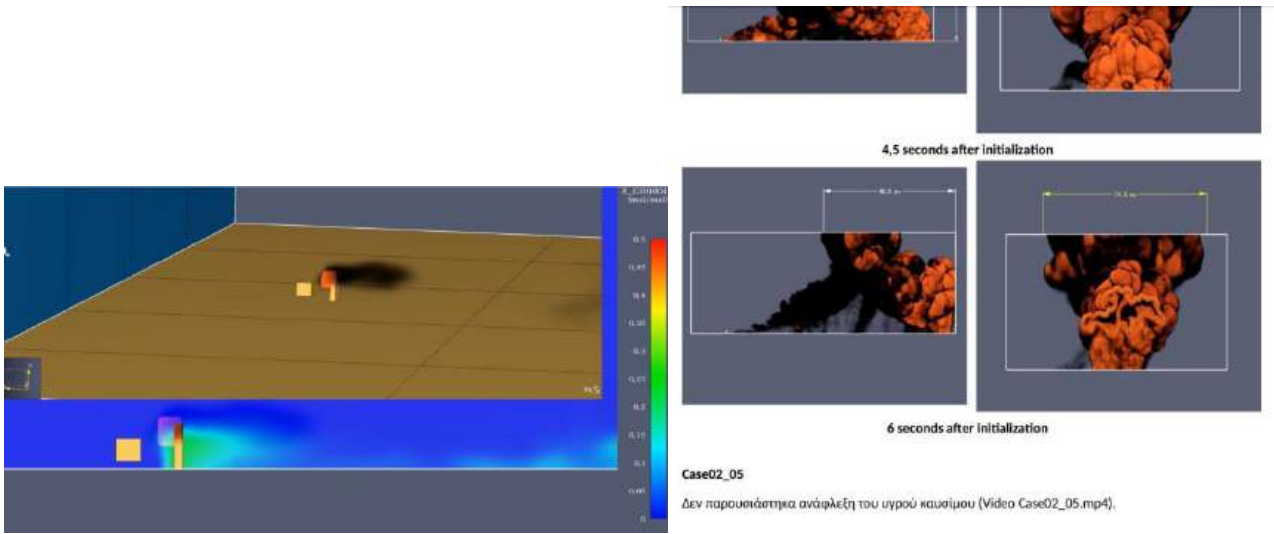
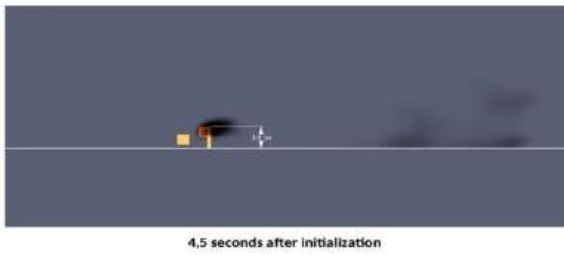
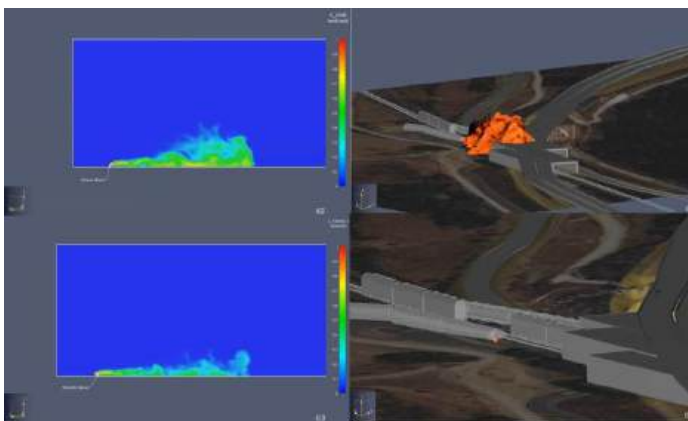
Various tests were run in order to simulate the possibility of silicone oil actually igniting in the presence of a heat source, in the form of an open flame (a pool fire inside a large bucket) or a heated vertical plate. Silicone oil was considered already atomized in small droplets of 500nm (much smaller than the 1000-4000nm as estimated by the RI.SE. report) and the total quantity of fuel was blown in particle form against a heated wall or an open flame. Several simulations were run using different geometries of release and dispersion and different values of AIT (auto-ignition temperature), starting from the realistic value of 450C and going down to 350C as suggested by UGent in order to simulate the possibility of piloted ignition, and even down to 250C which is an unrealistically low value that would be representative of less safe mineral oils.

The results of these tests rule out the possibility of PDMS silicone oils creating such a big fireball and pool fire, as the only possible result is a small localized ignition that will not propagate through the rest of the material, even if the total quantity of silicone oil is unrealistically atomized and dispersed all over the area.

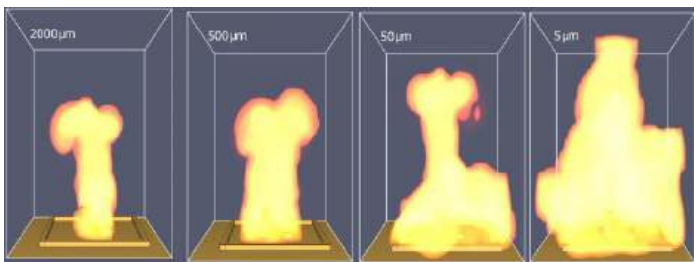
Droplet size (particle diameter) was evaluated and a comparison was run between particle diameter of 5, 50, 500, 2000μm in a particle release of similar characteristics to the one used in the final model. It was observed that there was a considerable difference when droplet size was very small (5 and 50nm) in comparison with the chosen value of 500nm, but for the larger diameter of 2000nm the effect was much smaller, indicating that in order to study an event with millimeter-sized droplets, 500nm particle diameter is deemed reasonable.

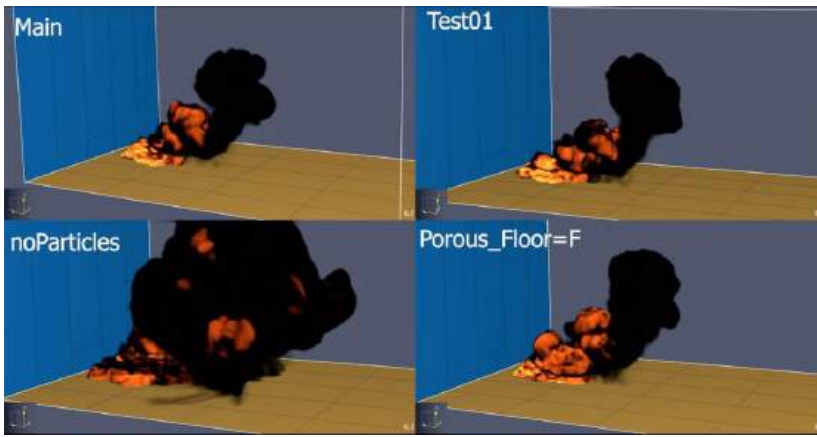
Also, a comparison was run between different amounts of liquid, gas and combined liquid and gas state of the same fuel, in order to validate the sensitivity of the FDS software to changes of state of fuel. Due to lack of any information relevant to volumes of fuel and their headspace, it was decided that no assumption would be made on this issue and the total amount of fuel would be considered as liquid particles.

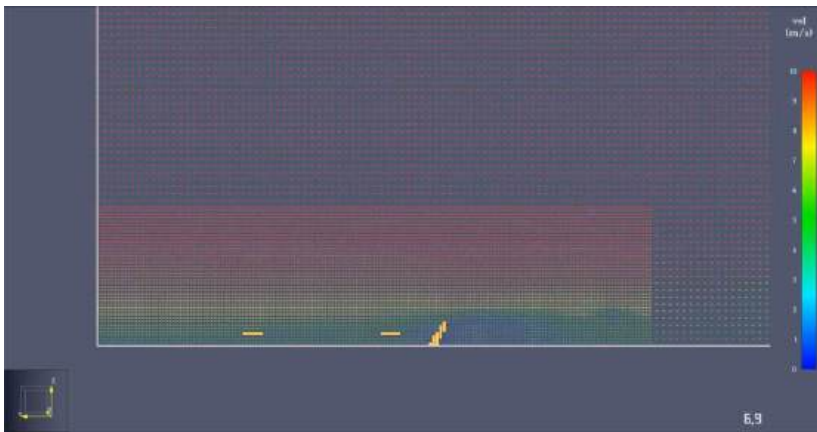
Boundary conditions were also compared in various small scale tests that gave an indication of the effects of the wind profile to the shape of the fireball. It was understood that small changes in the wind profile could affect the shape but not the maximum diameter, the rate of development of the phenomenon or the total duration of the fireball, so a realistic wind profile as close as the meteorological conditions of that day was used with the understanding of the small effect in the end result.

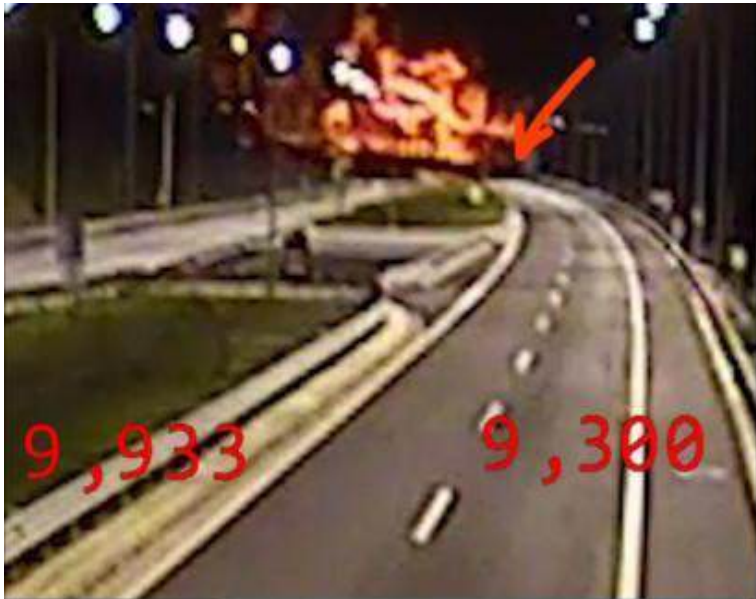
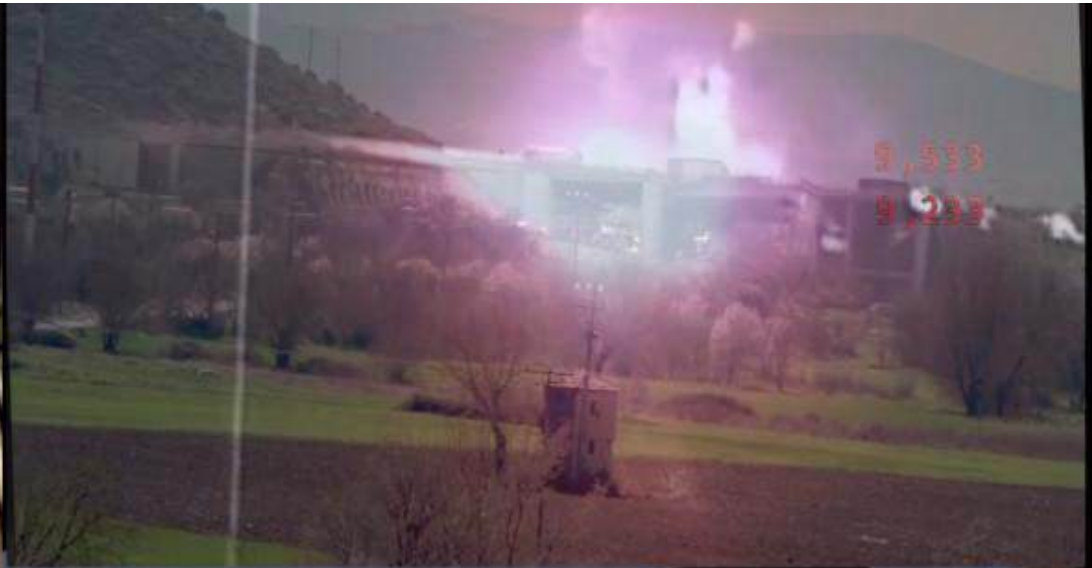
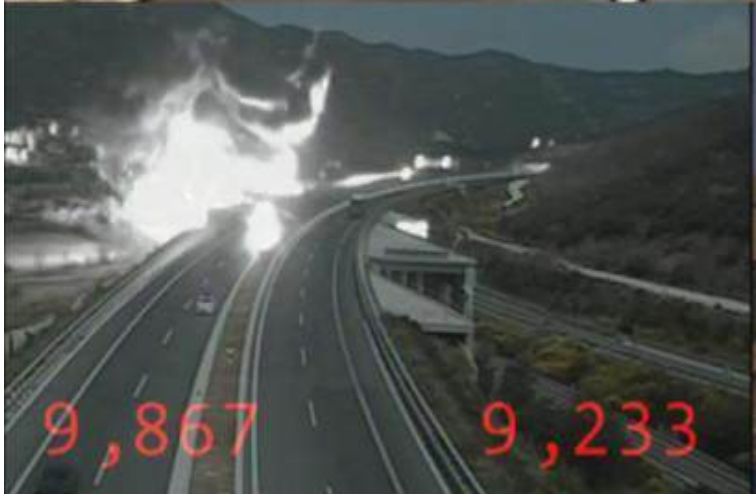
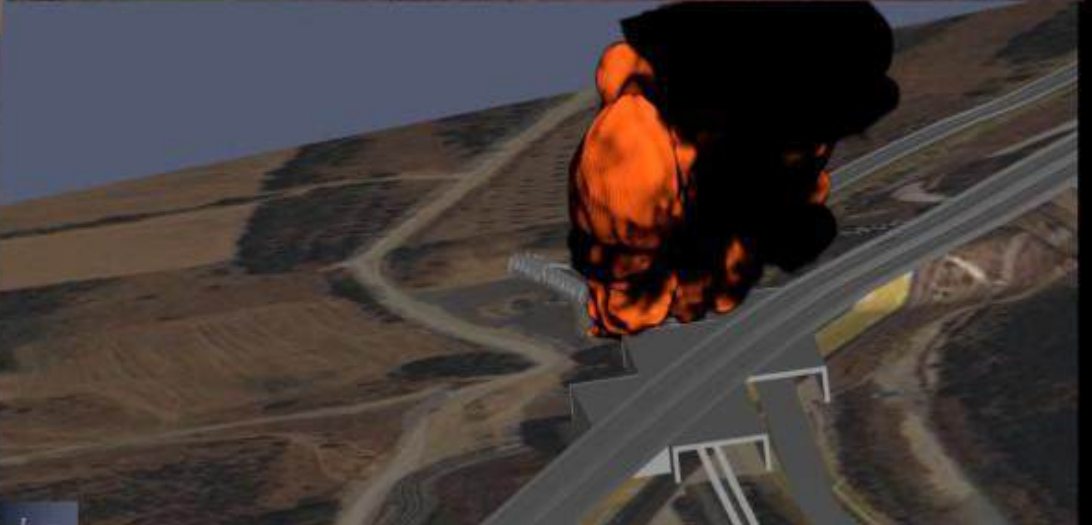
As for the Stage 1 initial release, a comparison of different possible geometries and initial speeds of fuel release showed that the most realistic results were obtained when the fuel particles were blown towards an obstruction with an inclination that would deflect part of the fuel spray upwards and another part to the side. After testing 12 different combinations of fuel quantities and fuel speeds for the two releases, the one most closely resembling the recorded video was Case08_07 with respective quantities of 800 kg for stage 1, 1200 kg for Stage 2 and 300-500kg for stage 3 pool fire. Obviously, this is only to provide an order of magnitude and not an exact number, as there are other combinations of fuel, velocities and geometries that could possibly replicate the target video. It is clear, though, that the order of magnitude is correct, as it is not possible to create a comparable sized fireball without at least 2000kg of fuel. Furthermore, absence of a large pool fire #1 as recorded by video evidence, rules out the possibility of a larger quantity of fuel (e.g. 10-15tn) that would have created and sustained a large pool fire as an aftermath to the crash.
